URGENT – Field Safety Notice

Bent pedal of footswitch might cause interruption of live Fluoroscopy imaging or exposure.

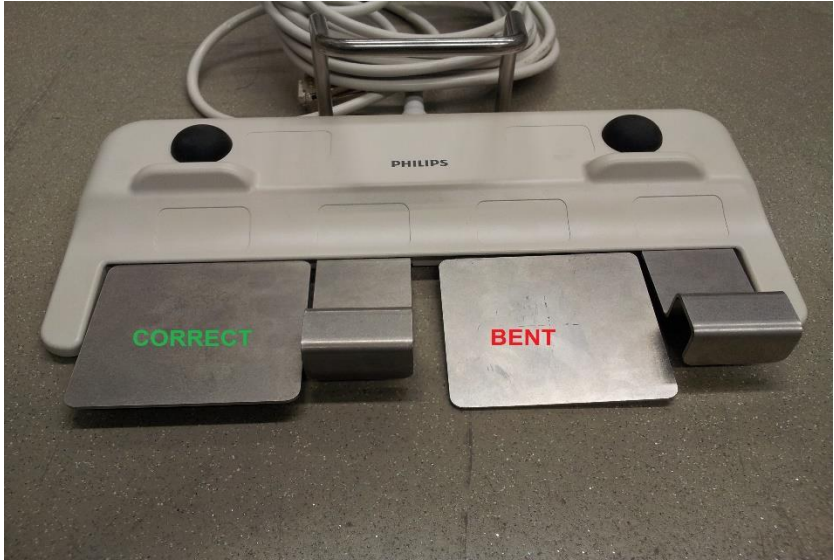
Philips noticed that due to a bent pedal of the footswitch, loss of image functionality is possible (intermittent or continuous inability of making live fluoroscopy images or exposures). The pedal may get bent when the footswitch is frequently used on an anti-fatigue mat or on a not flat surface or in the pedestal.

<p><i>Left pedal is correct. Third pedal from left is bent. Distance to floor should be approx. 12mm (0,47inches).</i></p> <ul style="list-style-type: none"> Do not use the footswitch on an anti-fatigue mat or in the pedestal. Please ensure that all staff with access to the affected systems are informed of the content of this Field Safety Notice. Include this Field Safety Notice together with the documentation of the system until the system has been corrected by Philips.
<p>ACTIONS PLANNED BY PHILIPS</p>	<p>The problem will be resolved by an update of the mechanical hardware of the Footswitch that will prevent that the pedals of the footswitch becoming bent.</p> <p>This mechanical hardware is available by February 2019.</p> <p>You will be notified by your local Philips representative to schedule a date for installation of this mechanical hardware update.</p>

<p>ACTION TO BE TAKEN BY CUSTOMER / USER</p>	<ul style="list-style-type: none"> Before the start of a procedure, the user must check the footswitch for possible bent pedals. See images below on how to identify a bent pedal. If bent pedals are found the procedure should not continue and Local Service should be contacted.
