URGENT Field Safety Notice

Trilogy Evo O₂, Trilogy Evo Universal, Trilogy EV300
Accuracy of FiO₂ Delivery

01 MAR 2023

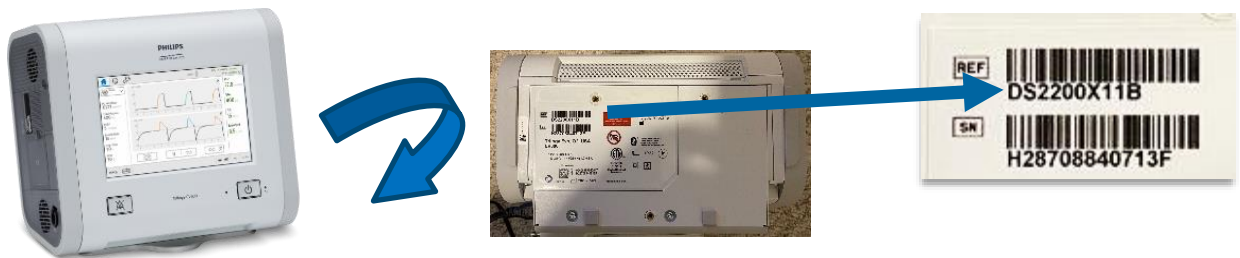
To identify the model, refer to the part number on the bottom of the device with the attached list of impacted part numbers:
