URGENT MEDICAL DEVICE CORRECTION NOTIFICATION
URGENT FIELD SAFETY NOTICE

Subject: Potential failure of AlignRT to assert interlock.

Commercial name of product: AlignRT.

Reference/FSCA identifier: 3010769039-15/10/14-001-C (Vision RT reference).

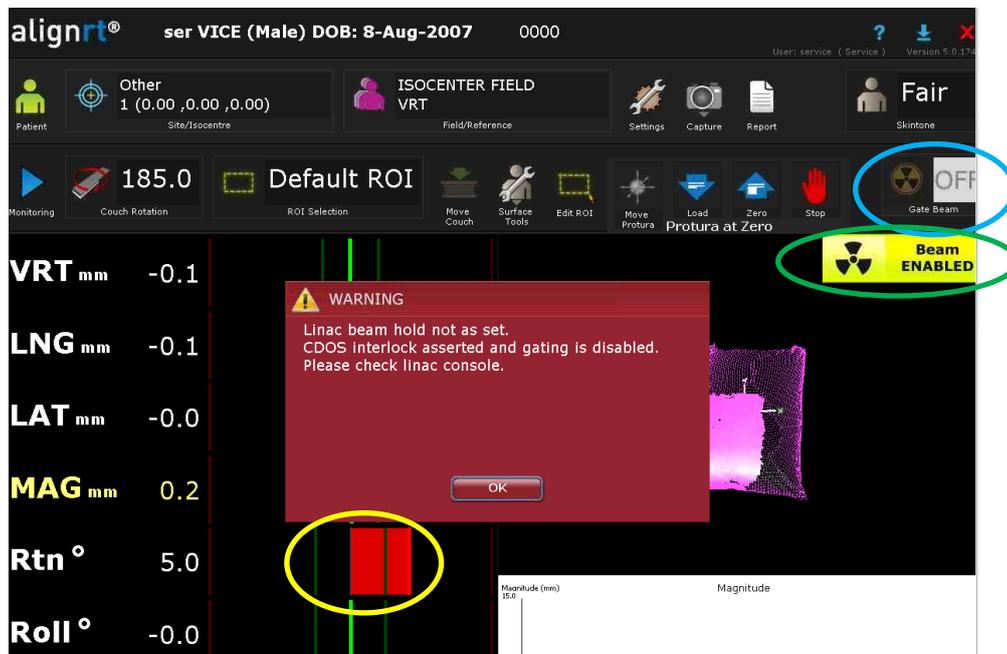
Figure 1: Warning message.

When patient motion that exceeds a pre-set tolerance is detected by AlignRT, in rare circumstances and only for the affected configurations referenced above, AlignRT may display a Warning Message on the main screen (see Figure 1) that states a beam hold interlock has been asserted, when in fact no interlock has actually been asserted on the C-Series Linac. Instead, in such circumstances, the beam will be enabled.

As illustrated below in Figure 1, the issue is readily detectable by the user from the AlignRT User Interface because, in addition to the Warning message, the system correctly shows that the Gate Beam functionality is OFF (blue circle), that the beam is currently ENABLED (green circle), and that the real time deltas are out of tolerance (yellow circle in the example). Additionally, the C-Series console should provide visible and audible indication of the actual status of the beam.

When AlignRT displays this message, the software may no longer be controlling beam delivery on the C-Series Linac, which will continue to deliver dose until manually stopped. If the user does not detect the anomaly and does not take appropriate action in a timely fashion, **the issue may lead to the delivery of an unintended dose of radiation.**

Vision RT has already disabled the MMI interface on all affected devices and did so within 48 hours of identifying the issue.

Vision RT is designing an upgrade that will resolve the issue, and will subsequently contact you in order to install the upgrade on your device. Until the upgrade is available the automated beam-hold function will remain disabled.
