## Urgent Field Safety Notice

<b>Commercial name of the affected product:</b>	Keeler Wall-plug Power Supply
<b>Part number:</b>	EP29-32777
<b>Scope:</b>	This FSN will only affect Keeler product shipped prior to 1/1/2006
<b>FSCA identifier:</b>	CAPA 1096
<b>MHRA references:</b>	<b>2015/001/012/601/005 &amp; 2015/001/014/081/004</b>
<b>Type of action:</b>	Advisory Notice
<b>Date:</b>	10/2/2015 – issue 1
<b>Attention:</b>	Distributors and Users
<b>Transmission of this Field Safety Notice:</b>	This notice must be passed on to all those who need to be aware within your organisation; This must include: <b>Quality/Regulatory, Theatre, Maintenance</b>

This notice only applies to Wall-plug Power Supplies shipped prior to: **Jan 01 2006 and marked “MADE IN TAIWAN R.O.C.”**

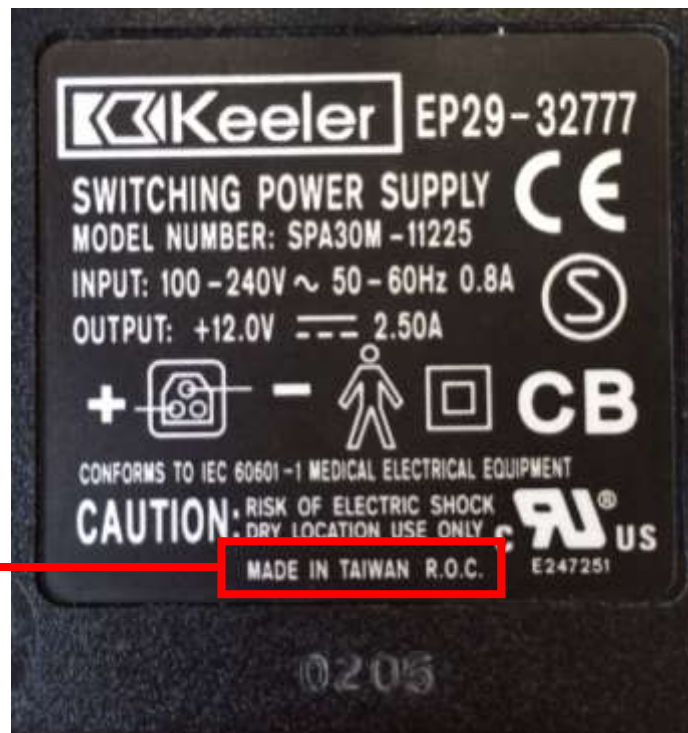
The Wall-plug Power supplies concerned carry a label as shown below and only those with identical labels and with the marking **“MADE IN TAIWAN R.O.C.”** are of concern to this notice.

Following investigations we believe that excessive impact or repetitive external knocks to the housing of the Wall-plug can lead to degradation of the internal insulation protection and/or sudden development of a hazardous electrical fault in the power supply. When subjected to physical damage some Wall-plugs can be rendered unsafe and pose a potential risk of electric shock.

These knocks and impacts are potentially more likely when the power supply is installed on a prolonged basis in positions making them prone to being hit by instrument / patient trolleys or any other room furniture.

- i) Check the label on the reverse side of the wall-plug. Only power supplies with an identical label to the above and with the marking "MADE IN TAIWAN" are of concern.
- ii) Check the physical appearance of the housing for any sign of damage, scratches, etc. The housing is of strong plastic type so even slight signs of damage are undesirable and would require replacement of the power supply.
- iii) Ensure that your test engineers carry out their regular Electrical Appliance safety tests. Replace the power supply if it fails the Isolation Resistance test.

- 1- Ensure your EP 29-32777 plug-in power units do not show any sign of physical damage.
- 2- Ensure that the power unit is plugged into a safe place and is not prone to knock and physical damage by moving trolleys, people and other equipment.
- 3- Ensure that the Portable Appliance Test is carried out on your equipment by qualified engineers at specified regular intervals defined by your local policy.
- 4- Ensure that old and/or damaged equipment is replaced with the latest standard equivalent

If you are concerned that your unit may be affected, please speak to your local Keeler representative to discuss replacing it. Investigations have confirmed that only power supplies marked with “**MADE IN TAIWAN R.O.C.**” are affected. You can contact Keeler directly:

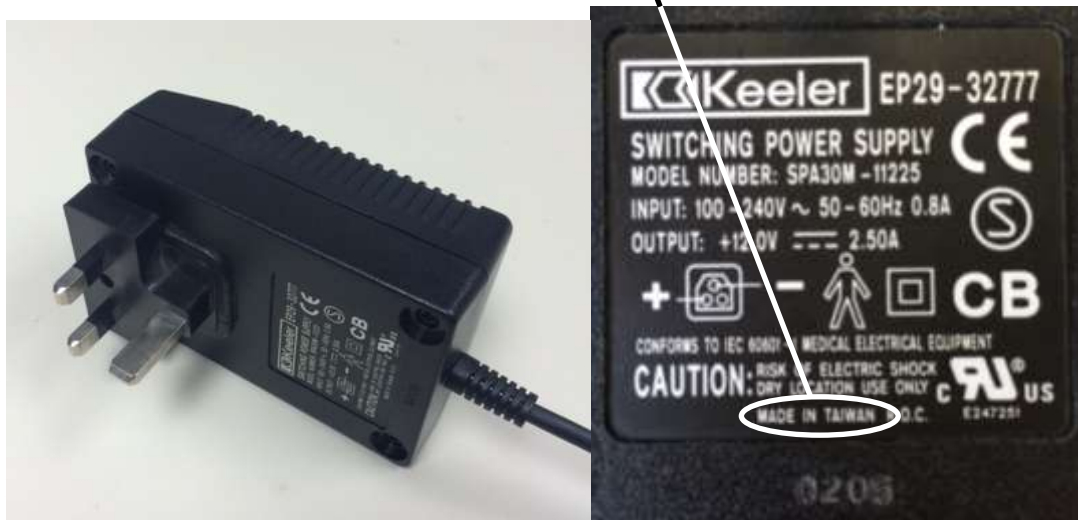
**EP29-32777 – MADE IN TAIWAN**

Keeler has established a discounted exchange program for the power supply unit marked:

These plug-in power supplies were in production between 2001 and 2006. Keeler will provide a one-for-one replacement if you feel you need to replace your unit after checking your unit and consulting the relevant field safety notice. Given the long (9+ years) length of service from your existing power unit and the 3 year new warranty carried by the replacement, we are setting the price for this exchange program at £45 each. This price excludes VAT and is conditional on you returning your existing power unit to Keeler. The discounted £45 price includes postage and also includes a pre-paid package for the return of your existing power supply.
