URGENT - Field Safety Notice

Philips IntelliVue Information Center iX (revision A.XX (where XX is 00 to 02) option LAB, PIIC iX revision B.00 option LAB and PIIC iX revision B.0 Enterprise Server (option LAB is bundled)):

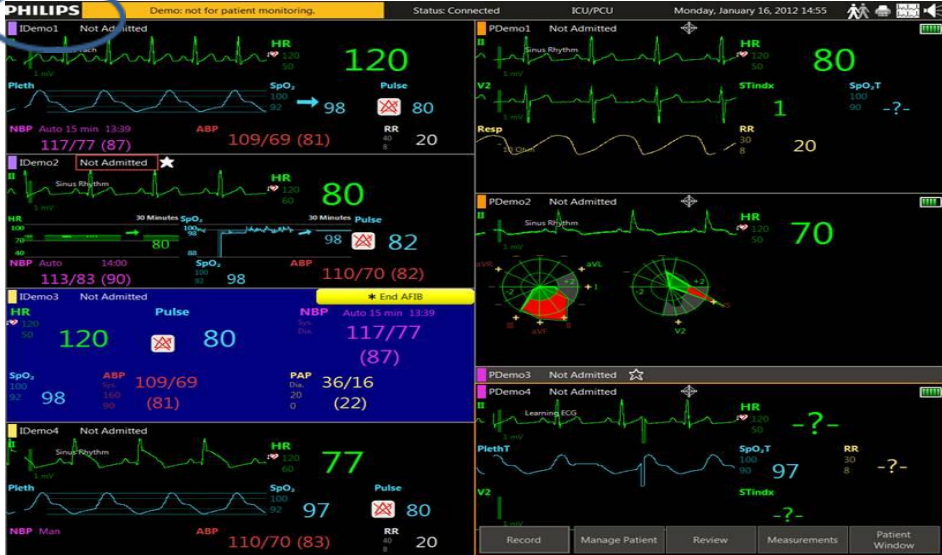
PIIC iX Revision – Identify the affected product by clicking on the Philips watermark on the PIIC iX surveillance display. This will bring up the Product Support Page.

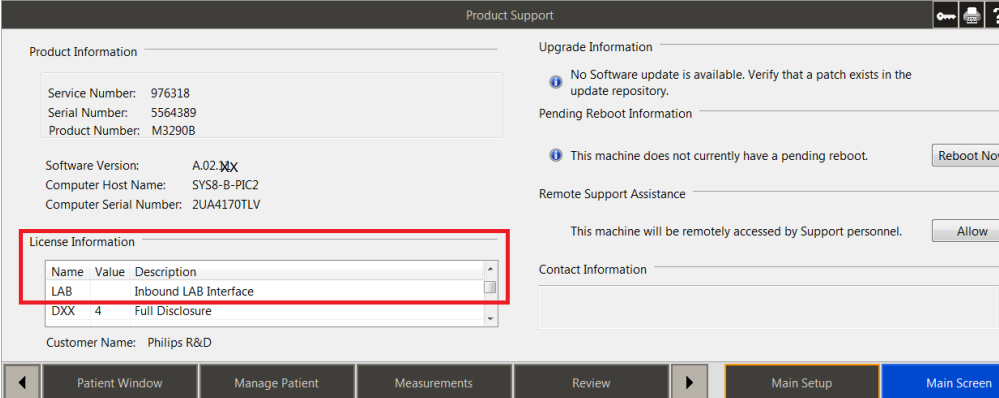
This screen shows the licensed features that have been included. All affected units will show the option LAB active in the License Information.
