Safety notice

Restricted use for Treatment chairs 500 XLE with serial numbers 2000-4506

Attachment to: Safety notice-Treatment chair 500 XLE-SN 2000-4506-27.04.2023

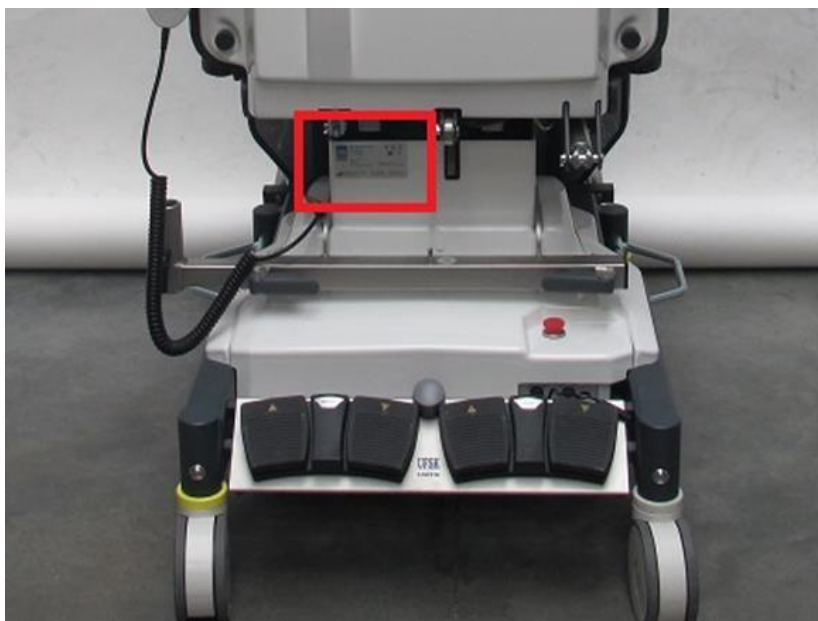
Where is the nameplate with the serial number (SN)?

Here you can find the nameplate of Treatment chair 500 XLE.
Identify the SN number! **Only SN-range of SN 2000 - 4506 is affected!**
