URGENT Field Safety Notice

Patient Information Center (PIC iX) and IntelliVue MX40
DHCP lease expiration re-connectivity issue between IntelliVue MX40 and PIC iX

22 -May-2023

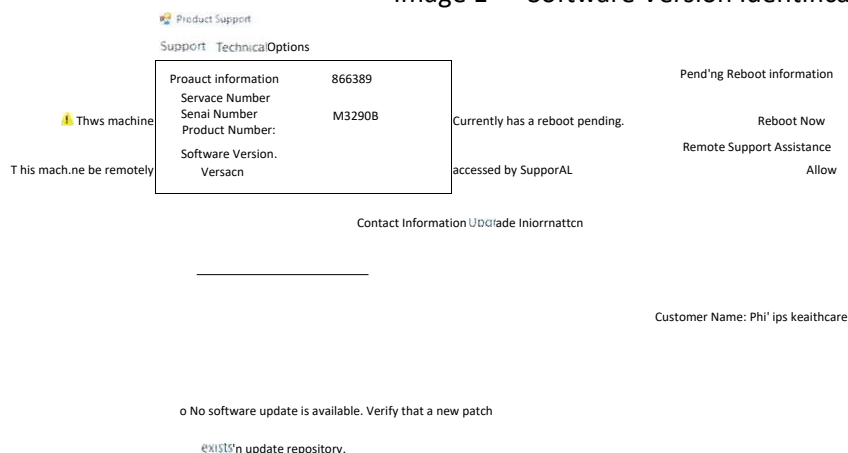
Image 1 — Software Version Identification

Access the Product Support screen by clicking the Phillips icon in your application. The PIC iX Software Serial Number and Software Version appear on the Product Support screen in the Product Information Section under Serial Number and Software Version respectively. Refer to Image 1 below:

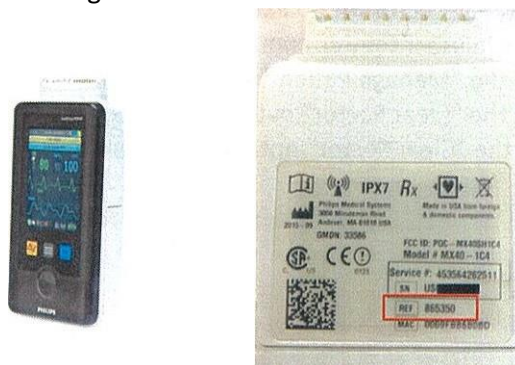
Image 2— MX40 device and rear label

The _____ can be identified by finding the Product Code listed on the label on the back of the MX40. The Product Code is listed under REF.
