Urgent: Field Safety Notice / 003-14

IH-1000

001000

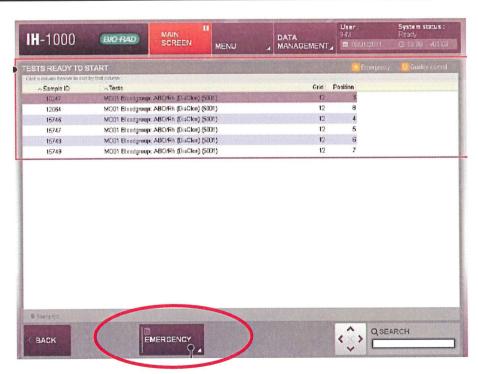
This information only concerns the use of the "Emergency button".

Further to a customer complaint, we have confirmed that in the specific conditions described below, the IH-1000 software may lose the link sample/"test in progress". This loss might in the worst case lead to a mismatch between the test result and the sample.

Our in depth investigation has determined this issue is linked to the sample management when using the "emergency button" and might occur **ONLY** in the following conditions:

In the meantime, customers should immediately discontinue using the "emergency button" and should process **ALL** emergency samples exclusively on the urgent rack (red label).
