Urgent Field Safety Notice (FSN)

Product Name: DePuy Synthes - ATTUNE® INTUITION™ Impaction Handle, ATTUNE® INTUITION™ Impactors

FSCA-identifier: HHE - 103077730 Impaction Handle / HHE – 103082178 Impactors

Date: Nov 2014

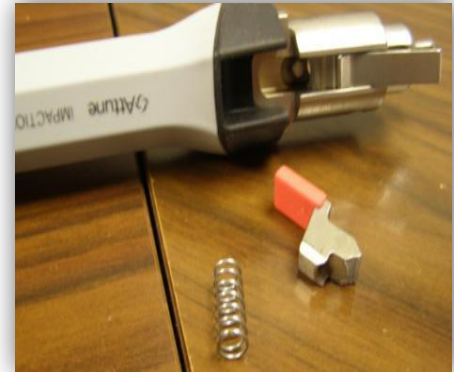
Complaints have been received indicating that the ATTUNE® INTUITION™ Impaction Handle (Part. no.254401017) lever has fractured during impaction. Should the lever fracture, there is the potential for fractured pieces of the device, or the inner spring, if released, to be left in the patient if not observed during surgery. The reported occurrence rate is 0.04%. No patient harms have been reported in cases where the levers have fractured.

Figure 3: Fractured ATTUNE® INTUITION™ Impaction Handle

To reduce the possibility of leaving fragments in patients, the company suggests adhering to the instructions for use (IFU), which include inspecting the ATTUNE® INTUITION™ Impaction Handle (Part. no.254401017) and Impactors (Part. nos. 254401003, 254401004, and 254401006) to ensure that no instruments or pieces of instruments are left in the surgical site prior to closure. The IFU is Part. No. 0902-00-836 Rev D. Highlights from the IFU include:

1. From Page 4 of the IFU: “Ensure that no instruments or pieces of instruments are left in the surgical site prior to closure, as they may not be detectable using imaging techniques such as X-ray or MRI and patient injury may result.”
2. From Page 5 of the IFU: “Visually inspect the instrument and check for damage and wear. Cutting edges should be free of nicks and have a continuous edge, jaws and teeth should align properly, moveable parts should have smooth movement, locking mechanisms should fasten securely; long, thin instruments should be free of bending and distortion.”

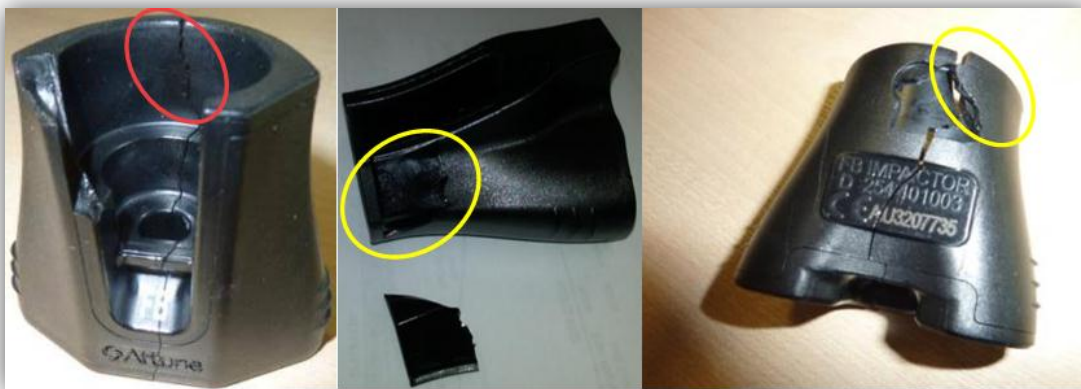
Complaints have also been received that the ATTUNE® INTUITION™ Impactors (Part. nos. 254401003, 254401004, and 254401006) have broken and produced small pieces. Should a fracture occur and not be observed during surgery, there is the potential for these small fractured pieces of the instrument to be left in the patient. No patient harms have been reported in cases where the impactors have fractured. The reported occurrence rates are as follows: 0.25% for fixed bearing tibial impactors (Part. no. 254401003), 0.08% for rotating platform tibial impactors (cat. no. 254401004), and 0.23% for femoral component impactors (Part. no. 254401006) is 0.23%.

Figure 4: Fractured ATTUNE® INTUITION™ Impactors
