FIELD SAFETY NOTICE

Dialog⁺ SW 9.xx Dialysis Machines

**in which the tubing between the level regulation block and the diaphragm pump
had been disconnected/reconnected in the course of any repair and maintenance
measures**

R-2015-004

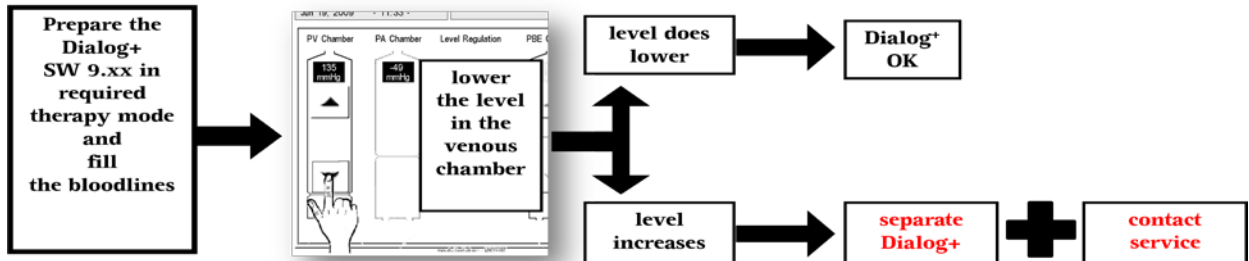
1. Prepare your Dialog⁺ machine in the required therapy mode as usual.
Fill the bloodlines.
The venous chamber should be half-filled.
2. Lower the level in the venous chamber by pressing the function key

.
3. Observe the level in the venous chamber
The level lowers ⇨ the level regulation is working correctly

The level rises ⇒ the level regulation is **NOT** working correctly
↓

Do not use the respective Dialog⁺ machine
Separate and label it
Contact your service technician
