Field Safety Notice
Urgent Medical Device Correction – 2955842-10/05/16-011-C
da Vinci® Xi™ Surgical System P5 Software

1- Introduction and Reason for Field Action

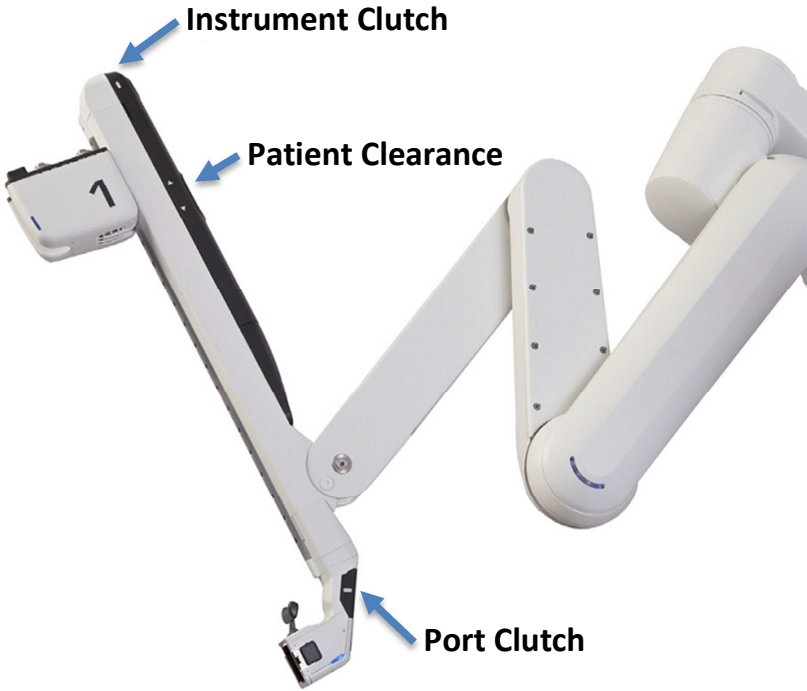
During an internal test, the left hand control (master) on the surgeon console moved unexpectedly upon the first entry into following mode. The system is in following mode when the surgeon is controlling the instruments at the surgeon console. This behavior was determined to be associated with a software anomaly in the *da Vinci Xi* Surgical System P5 software that can result in unexpected master movement and potential instrument tip movement under certain circumstances. A software update will be released to address this anomaly.

**CAUTION: Hold the port clutch button with one hand and support the cannula with the other.**

1. During **Single-Site** surgery, **after installing** each **instrument** on the sterile adapter, ensure **instrument clutch** is **not activated** and press the **port clutch*** button for that arm. This is only necessary at the beginning of the procedure, directly after docking.
2. During **Multi-Port** surgery,
 - a. Immediately **after docking** to a cannula, press the corresponding **port clutch*** button for that arm, and
 - b. If adjusting **patient clearance** mid-procedure, ensure instrument clutch is not activated and press the corresponding **port clutch*** button for that arm after the adjustment
