Urgent Field Safety Notice

Updated Maintenance Instructions for Shuttle Discovery with 4 Wheel Verve Stroller

Medifab Ltd Ref: I03450

Device Name: Shuttle Discovery with 4 Wheel Verve Stroller

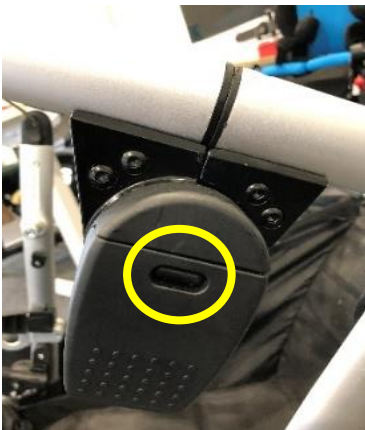
The folding mechanism on the Verve stroller is controlled by lowering or lifting a lever to lock or unlock the frame. To ensure effective locking is achieved, the tension in the joint must be sufficient, this is provided by a T bolt (shown in yellow circle) and an antivibration nyloc domed nut (shown in orange circle).

Folding lever in locked

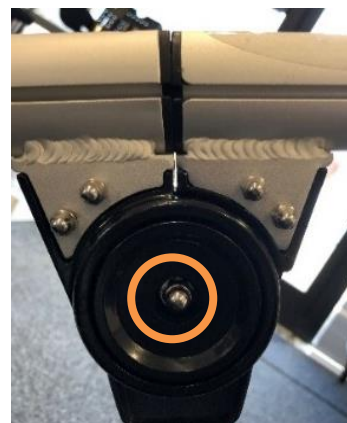
Folding joint and antivibration nyloc domed nut.

The product has been tested to withstand the expected vibrations in use. However, due to the variable nature of where and how the product can be used, a gap may develop over time at the folding joint which can be easily corrected by tightening the antivibration nut during routine maintenance.

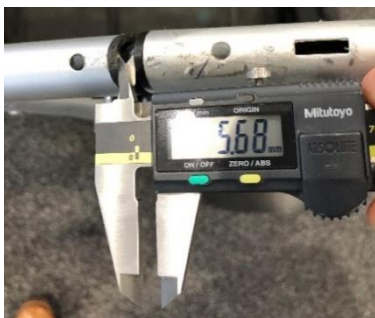
If the antivibration nut is overtightened, it will damage the T bolt within the folding joint which will lead to a greater gap at the folding joint. This could provide a finger entrapment for the user and anyone interacting with the frame, potentially leading to serious injury,

We have been notified of an incident where the T bolt has been damaged due to overtightening of the nyloc nut leading to a serious injury to a user.

Damaged T-Bolt The metal section of the T bolt is exposed and appears bent

If the plastic shroud covering the head of the T bolt is broken or missing please stop using the product and contact your Shuttle Discovery distributor, health care provider or Medifab to arrange the fitting of a replacement T bolt.
