Customer Advisory Notice CT057/20/S

**Force
Definition AS
Definition Edge
Definition Flash
Drive
Confidence
EdgePlus**

running syngo.CT VB20A_SP2

Subject: Technical issue with several SOMATOM CT scanners running on syngo CT VB20A_SP2, solved with the new service pack VB20A_SP3

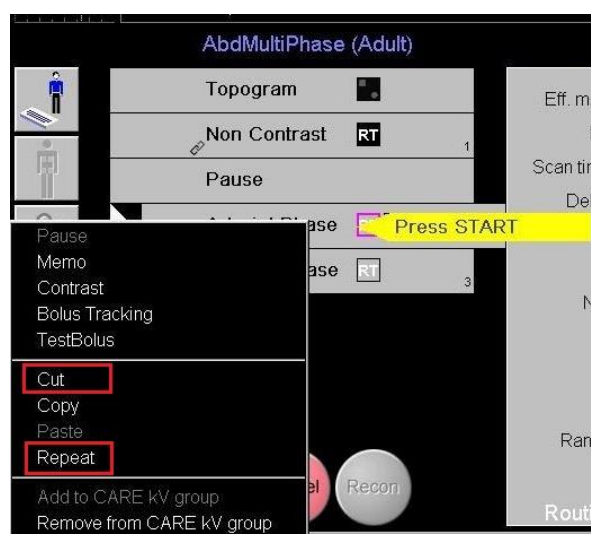
- A scan is loaded and the control box is flashing ("Press start" yellow message bubble is displayed) **and subsequently**
- A scan of the loaded protocol is cut or repeated (see Fig. 1)

Fig. 1: Context menu (right mouse click) offering the functions "Cut" and "Repeat" of a scan selected in the chronicle

In this situation it may be the case that the system will no longer accept any potential change to a scan or reconstruction-relevant parameter. Erroneously the changed parameters are displayed in the graphical user interface, but in fact the previous settings remain unchanged. Consequently, the original parameters will be used for the scan already loaded when the X-ray generation is started.

As the root cause, we found that the system does not trigger a cancel command followed by a reload of the scan with the new parameter(s).

Please cancel the scan already loaded **before** cutting or repeating an entry.

This issue will be solved by an improved syngo CT VB20A_SP3 software version. A service pack will be rolled out free of charge with the update CT056/20/S for all affected systems. Its release is planned for the end of Q4/2020. All future service packs will contain the fix as well.
