Field Safety Notice: FSN-2023-09-27

**MICRO FEATHER DISPOSABLE OPHTHALMIC SCALPEL
WITH PLASTIC HANDLE**

This letter is to inform you of a **Field Safety Corrective Action** initiated by the manufacturer FEATHER SAFETY RAZOR CO., LTD., JAPAN for the affected **Ophthalmic Knives**.

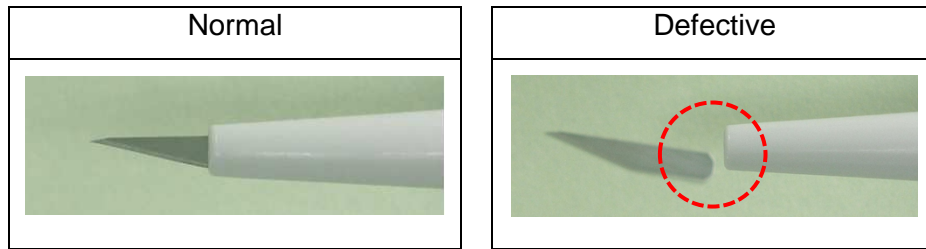
The manufacturer found out that the plastic handle of the product changes over time for some reason, resulting in weakening of the fixing strength which can cause the blade to fall out of the handle.

Internal tests on aged goods have shown that the probability of the defect occurring increases after approx. 6 months.

Feather came aware of the defect by customer complaints. To date, there have been no reports of incidents associated with the defect. The manufacturer has initiated a root cause analysis for the product defect. Since the defect occurred after the changeover of the production process in 2022, it could be isolated to the affected batches.

3. Type of Action to mitigate the Risk	
3.	1. Action to be taken by the Customer
	<input checked="" type="checkbox"/> Identify Device <input checked="" type="checkbox"/> Quarantine Device <input checked="" type="checkbox"/> Arrange the return or, after consultation with the supplier, arrange for destruction
3.	2. Is Customer Reply Required?
	The completed reply form is required as proof and for reimbursement.
3.	3. Action Being Taken by the Manufacturer
	<input checked="" type="checkbox"/> Product Removal <input checked="" type="checkbox"/> Corrective / preventive measure to eliminate the product defect
