**URGENT - Field Safety Notice**  
**Allura Xper Systems**  
**Bent pedal of footswitch might cause**  
**interruption of live Fluoroscopy imaging or exposure.**

A problem has been detected in the Philips Allura Xper Systems that, might intermittently lead to interruption of live fluoroscopy imaging or exposure. This Field Safety Notice 72200248 is intended to inform you about:

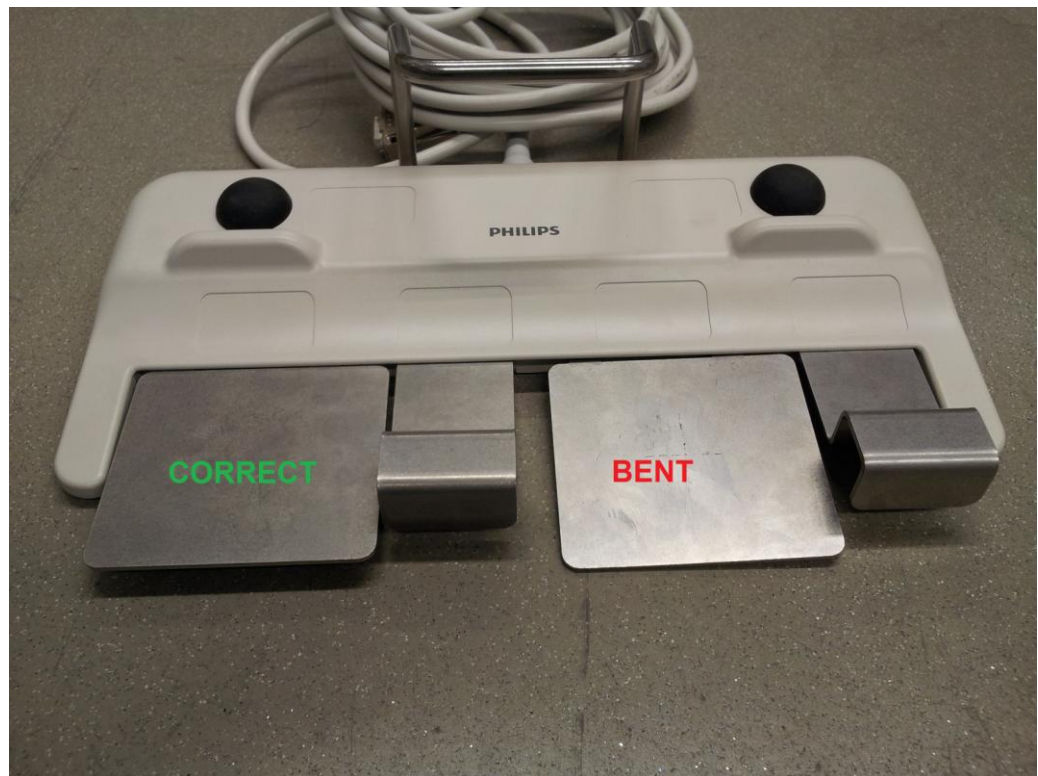
Left pedal is correct. Third pedal from left is bent.  
Distance to floor should be approx. 12mm or 0,47inch.

<p><b>ACTIONS PLANNED BY PHILIPS</b></p>	<p>A Mandatory Field Safety Corrective Action will be issued to solve this problem. This Field Change Order (FCO) will be identified as FCO72200248 and will be free of charge. Planned issue date is end of December 2014 latest. This FCO consists of a Mechanical Hardware update of the Footswitch in order to prevent bent pedals and therefore prevents an intermittent or continuous inability of making live fluoro images or exposures.</p>
<p><b>FURTHER INFORMATION AND SUPPORT</b></p>	<p>If you need any further information or support concerning this issue, please contact your local Philips representative or the UK Philips Customer Care Centre on 0870 532 9741.</p>
