Urgent Field Safety Notice (FSN)

Product Name: DePuy Synthes - ATTUNE® Intuition Distal Femoral Jig

FSCA-identifier: HHE-103070405

Date: Oct 2014

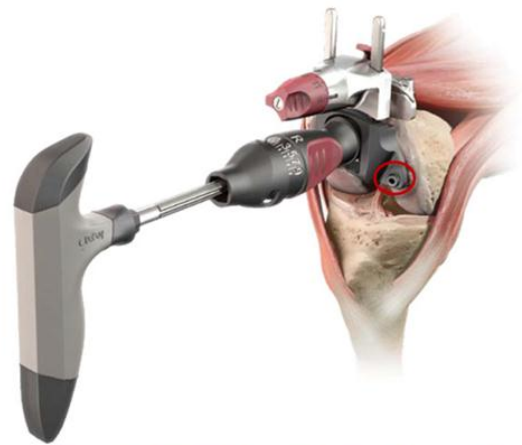
Figure 1: ATTUNE® Intuition Distal Femoral Jig

During the company’s complaints investigation, it was determined that the metal pin bushing has the potential to be displaced during use and therefore allow plastic debris to break from the instrument. This is potentially caused by excessive loading applied during pinning of the jig to the distal femoral condyles. The complaint rate of the bushings partially or fully displacing is 0.018%.

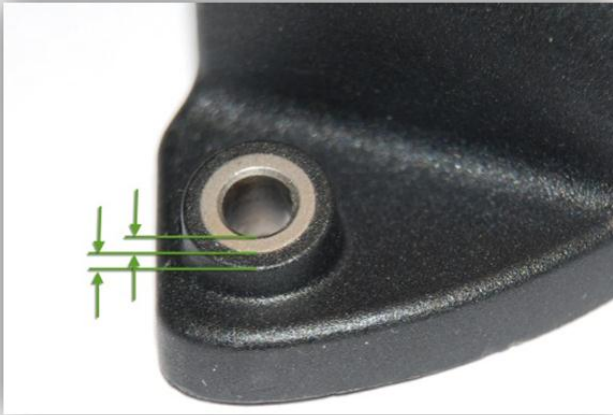
Correctly Assembled

Figure 2: The correctly assembled jig will have the smaller diameter (5.50 mm) end of the metal pin bushing on the jig’s top side. The incorrectly assembled jig will have the larger diameter (6.50 mm) end of the metal pin bushing on the jig’s top side. The incorrectly assembled jig has a wall thickness of the black plastic surrounding the bushing which is considerably thinner than the wall thickness of the bushing.

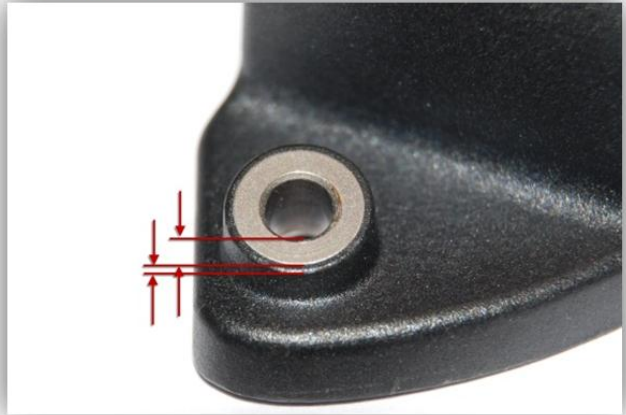
Figure 2: Top of Jig – Comparison of Correctly Assembled vs. Incorrectly Assembled (Inverted Bushing)

The company is advising an inspection of specific lots of the ATTUNE® Intuition Distal Femoral Jig (Part numbers 254400521 and 254400520), as those instruments may be assembled incorrectly. Theatre Staff and persons involved with the Cleaning and Reprocessing of the device are requested to inspect all inventory for specific lots see “Inspection and Swap-Out of Femoral Jigs for Incorrect Assembly” on Page 2. In the instance that a device is found to be assembled incorrectly it is requested to be returned and exchanged for a correctly assembled device.

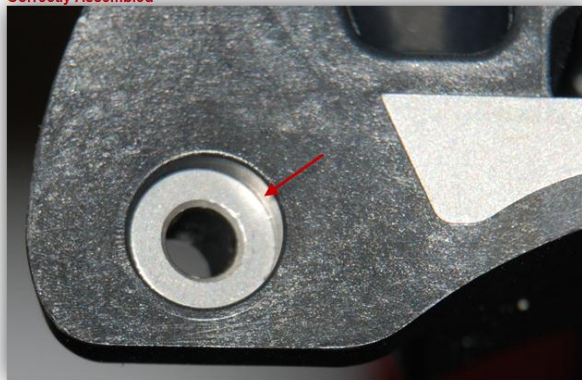
Correctly Assembled

Figure 3: The correctly assembled jig will have the larger diameter (6.50 mm) end of the metal pin bushing on the jig’s bone side (bottom side). The incorrectly assembled jig will have the smaller diameter (5.50 mm) end of the metal pin bushing on the jig’s bone side (bottom side).

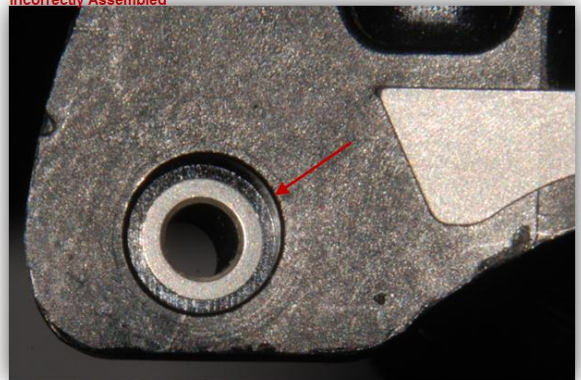
Figure 3: Bottom of Jig (bone side) – Comparison of Correctly Assembled vs. Incorrectly Assembled (Inverted Bushing)

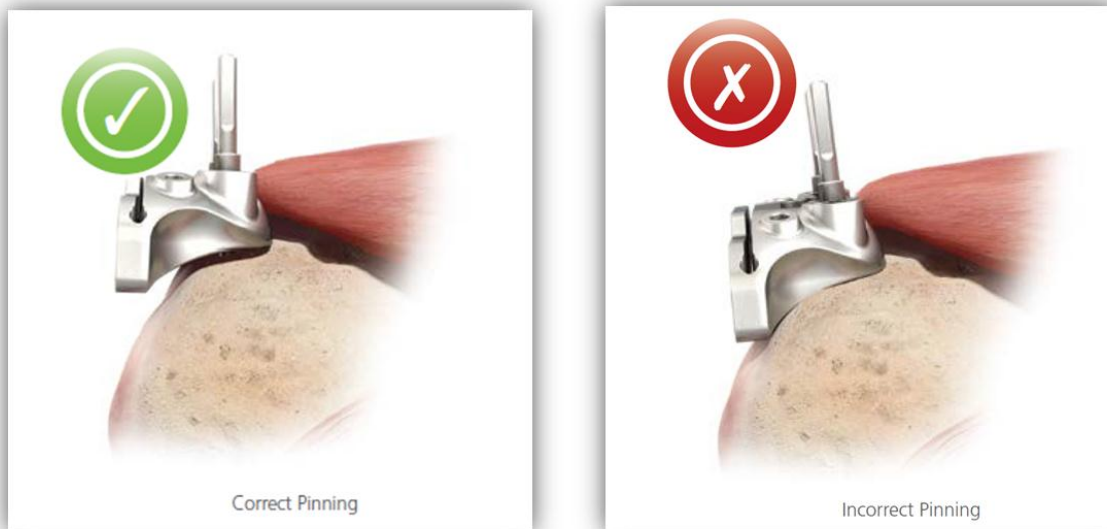
Figure 4: Images of Correct vs. Incorrect (over tightened) Pinning from Page 8 of the “DePuy Synthes Joint Reconstruction ATTUNE® Knee System Surgical Technique” (Cat. No. 0612-10-512)

1. Refer to Page 8 of the surgical technique. This section highlights that headed pins should not be over tightened against surfaces of uncut bone. It is recommended to not continue to drive the headed pin once the head contacts the bushing.

“Headed pins are best used to secure blocks against a flat surface such as cut bone, however, if used on uncut bone with a curved surface, be careful that the Headed Pins are not over tightened as this can lead to tilting and malalignment of the block.”
