**URGENT – FIELD SAFETY NOTICE**

**GETINGE ED-FLOW AER, ED-FLOW SD AER  
SOFTWARE UPDATE – Field Action 2016-01**

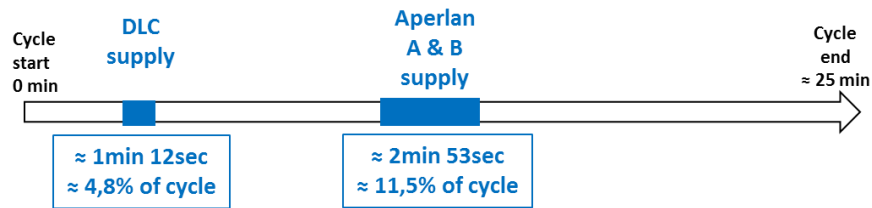
The issue we found can cause a lack of product supply (DLC detergent or Aperlan Poka-Yoke Agent A and Agent B disinfectant) if the compressed air supply of the machine is lost right before or during product supply, and after cycle start, and not re-established before cycle end (periods in blue on timeline).

*Duration of reprocessing cycle and product intake in an ED-FLOW or ED-FLOW SD AER*

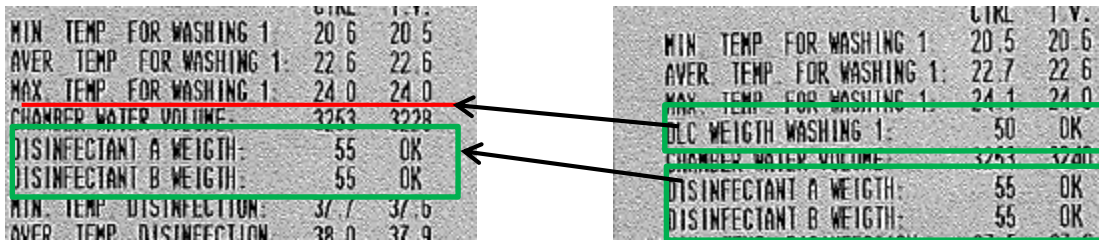
3. In the meantime, this issue can be detected by careful examination of the ticket printed at the end of each reprocessing cycle. **Please make sure to systematically check and record that there are 3 lines printed on the ticket (example below) :**

- DLC weight washing 1 OK
- Disinfectant A weight OK
- Disinfectant B weight OK

**Wrong ticket :**  
DLC line is missing

**Correct ticket :**  
all 3 product weight lines are printed

If any of these 3 lines is not printed, the reprocessing cycle was not performed properly. **You need to reprocess the endoscope to ensure proper washing and disinfection.**
