Urgent Field Safety Notice

**Microdot Droplet Pen Needle 4mm x 32G28G, type 810,
catalogue number 8065.**

FSCA – ZJ-S 379/2017

Date: 2017-10-12.

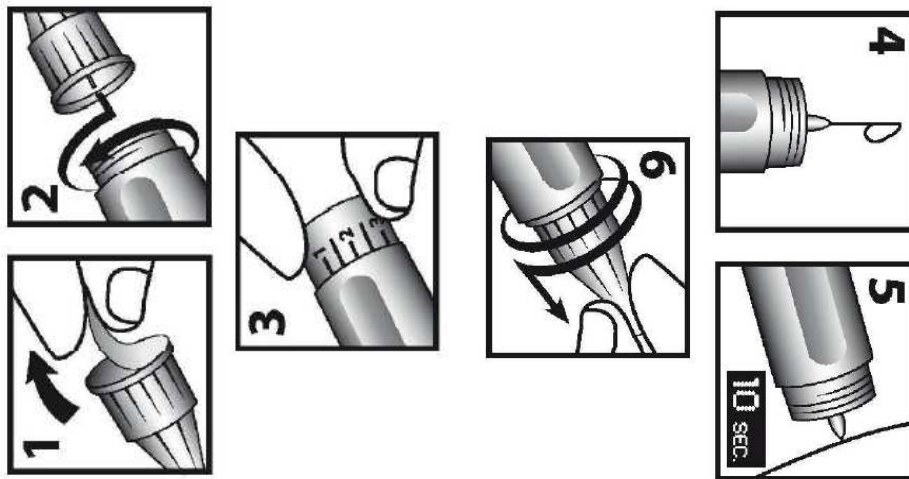
The most likely cause of the defect was incorrect removal of the cap or multiple recapping by the user.

The current IFU shows 6 steps of use of the device. The step related to correct removal of the inner and outer cap is not included.
