Urgent Field Safety Notice **Perfusion Tubing System Packs**

Date: October 09, 2017

Reference: CP-MIR-2017-001

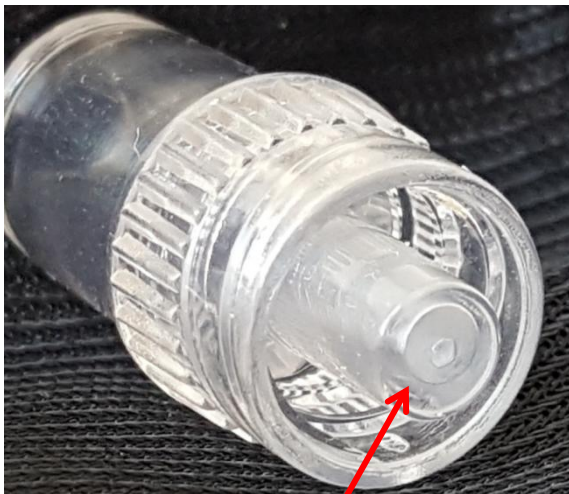
Complaints of difficulties draining fluid on lines included in the PTS have been reported. In all cases, partial occlusions of the luer connector were noted by customers. Investigation determined that the reported connector occlusion was generated during molding of one specific lot of luer.

NOT CONFORMING

1. Open the connection or remove the protection cap from male luer connectors.
2. Visually inspect male luer connectors for occlusion. Refer to the pictures below to determine conformity of the luer.
3. Restore connection as needed.
4. If a non-conforming luer is identified or in case of doubt, replace the PTS with a new one and contact LivaNova.

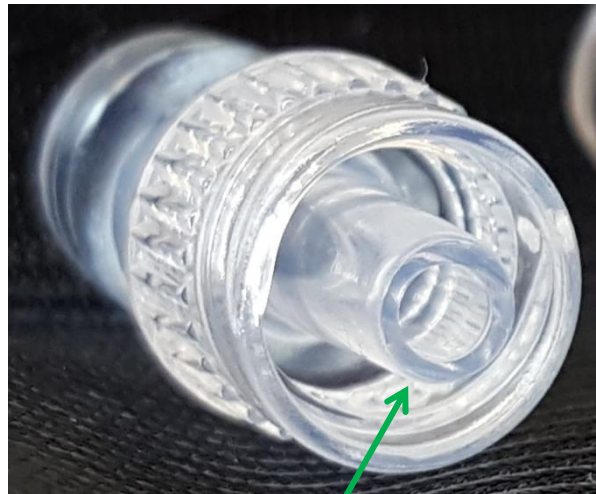
CONFORMING
