Field Safety Notice #271391 related to *exoplan 3.1 Rijeka*

This Field Safety Notice (FSN) contains important customer information for patient safety and for the safe use of *exoplan*, our software for implant planning and surgical guide design.

exocad product, commercial name: *exoplan 3.1 Rijeka*

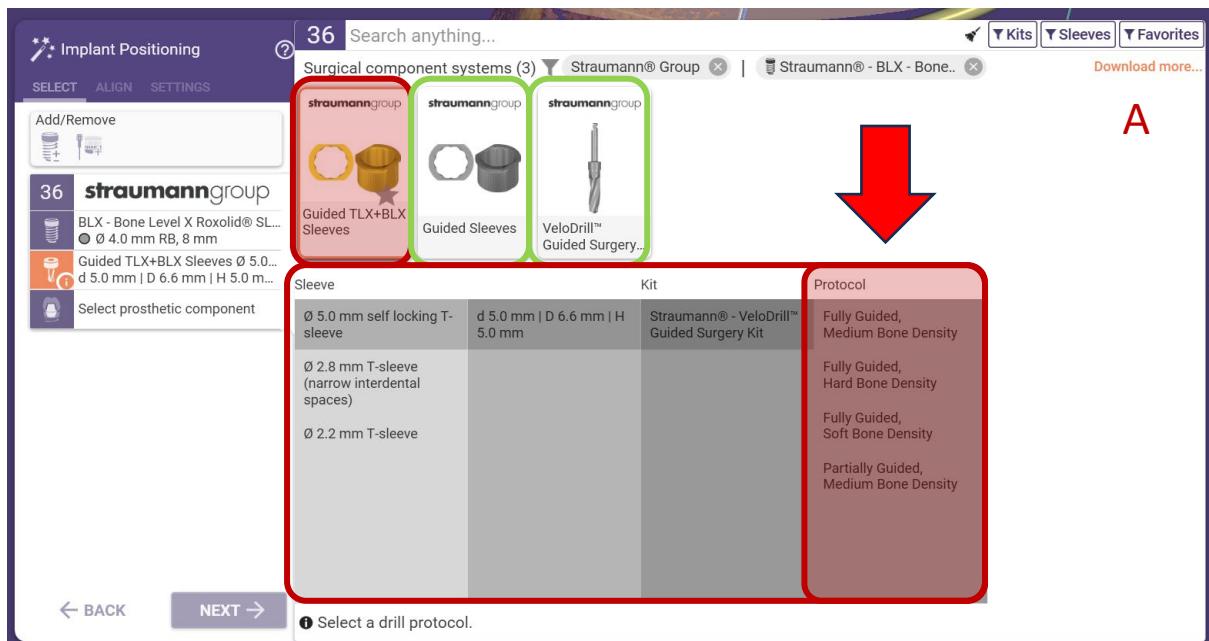
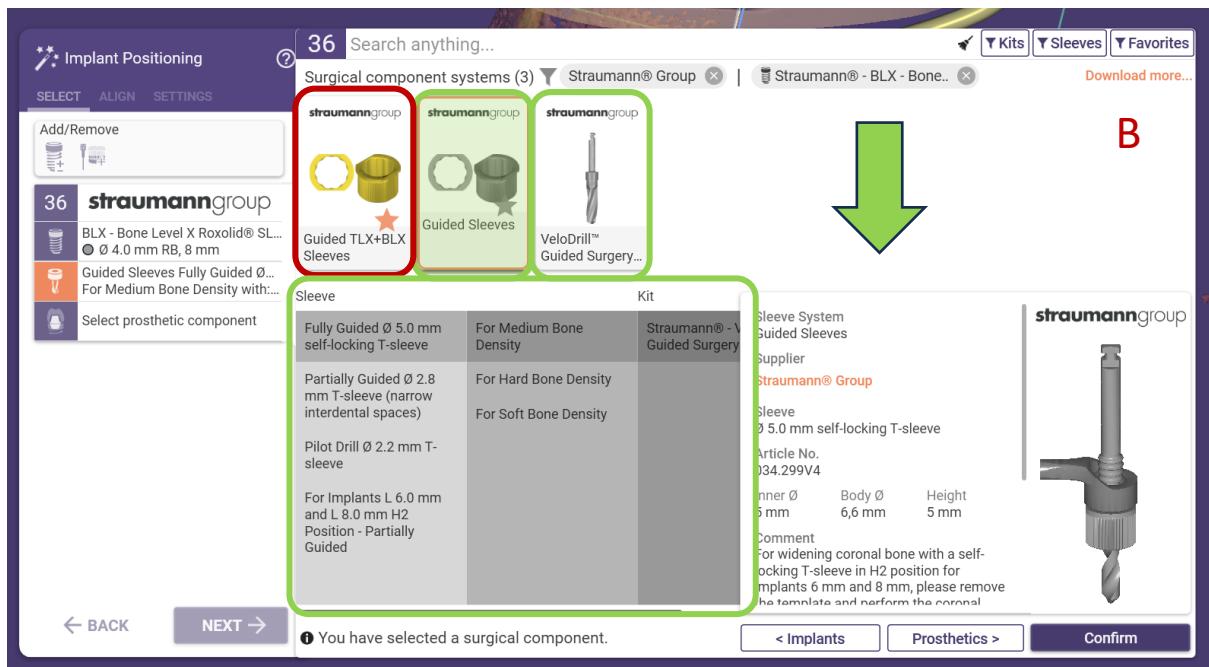
Figure 1: Examples comparing between selecting a “protocol” library (case A) and selecting libraries without protocol (case B). The picture shows all entries that should not be used in red. Those that can be used without interference are marked in green. If no “Protocol” column is present, the library is not affected by this FSN.

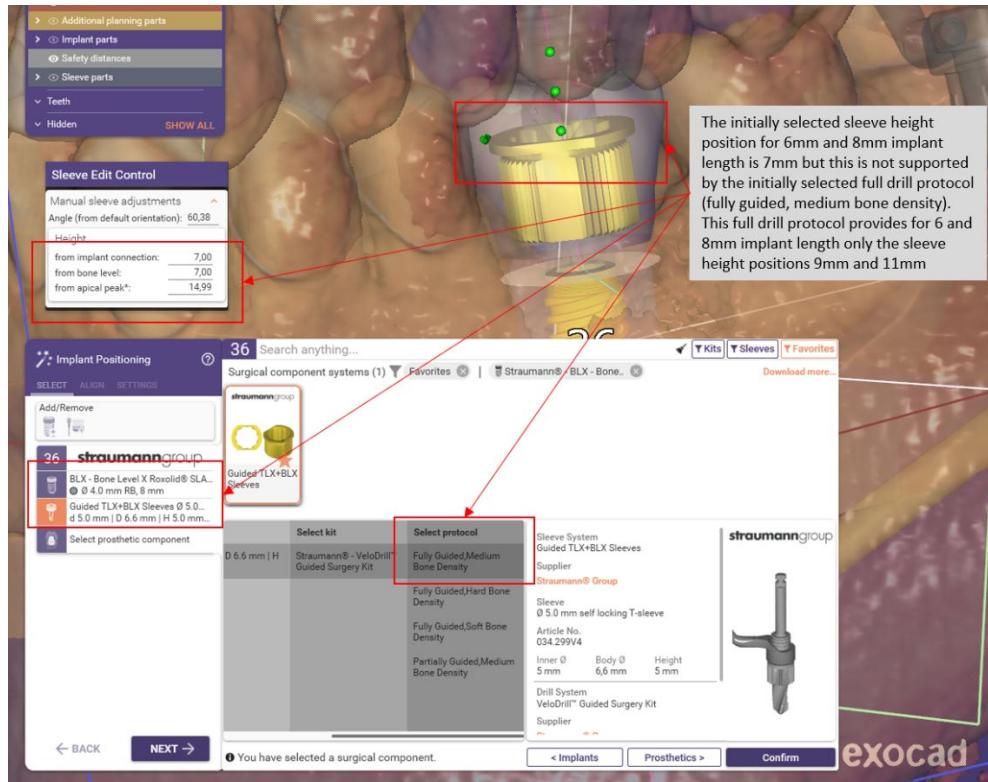
When a Straumann® BLX/TLX implant with 6 mm or 8 mm length in combination with a Straumann® BLX/TLX sleeve and the Straumann® VeloDrill-kit with full drill protocols is used, the software places the sleeve for the initially selected full drill protocol "Fully Guided Medium Bone Density" to a height position of 7 mm (see figure 2). For this protocol, however, only 9mm and 11 mm are allowed. Internally, the software selects the full drill protocol for a sleeve height position of 9 mm and shows this also in the surgical protocol (see figure 3). If a user follows the full drill protocol sequence from the surgical report when printing and using this guide with that wrong sleeve position, the drill depth would be 2 mm deeper than planned and might damage anatomical risk structures close to the implant apical positions (e.g., nerves, or neighbored tooth roots).

Figure 2: Example of one critical combination between unsupported sleeve height position for the selected full drill protocol. See explanation in the image.

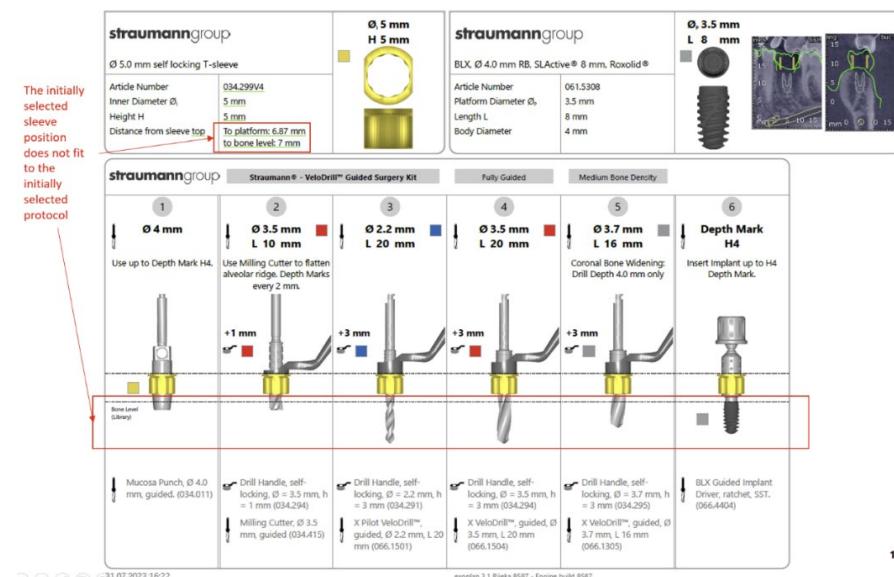
Figure 3: Extract from the surgical report that depicts the mismatch between the initial sleeve height position and the full step-by-step drill protocol where the distance from sleeve top to implant shoulder is incorrect.
