**FIELD SAFETY NOTICE****LINET ELEGANZA STANDARD & DELUXE MODEL BEDFRAMES (PREFIX 1GS... & 1GL...)**

**Type of action: Inspection & fitting of weld strengthening brackets.**

FSN-A0025

Issue Date: 15-07-2011

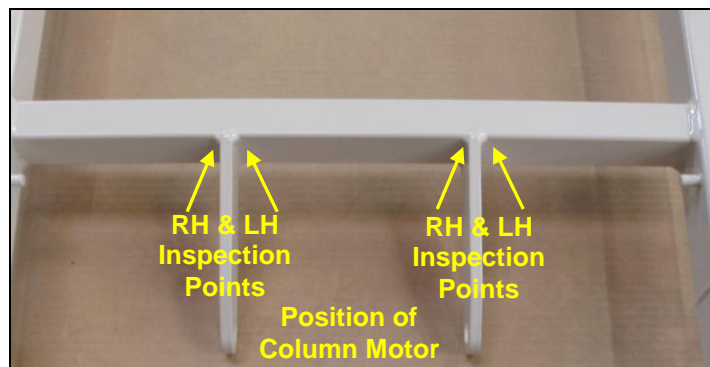
**Fig 01****Bedframe Footend Inspection**

1. Using the Supervisor Control Panel / Patient handset raise the Backrest to its full working height.
2. Inspect the weld joints as detailed in fig 01 below. Ensure the paint surrounding the welds is not flaking, showing signs of rust and the weld joints are intact. Inspect both the RH and LH weld fillets, above and below the Mattress Platform.
3. We would recommend that Bedframes displaying the above symptoms are removed from service at the earliest opportunity for the fitment of the strengthening brackets.

- If evidence of any cracking welds is identified, we would recommend that the bedframe be removed from service at the earliest opportunity for the fitment of the strengthening brackets.

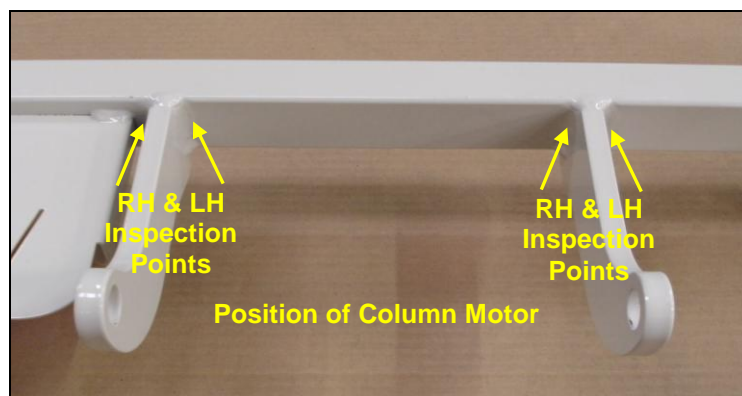
**Fig 02**

1. Using the Supervisor Control Panel / Patient handset raise the Kneebreak together with the mechanical Legrest Ratchet, to its full working height.
2. Inspect the weld joints as detailed in fig 02 below. Ensure the paint surrounding the welds is not flaking, showing signs of rust and the weld joints are intact. Inspect both the RH and LH weld fillets, above and below the Mattress Platform.
3. We would recommend that Bedframes displaying the above symptoms are removed from service at the earliest opportunity for the fitment of the strengthening brackets.
