Urgent Field Safety Notice

Subject: Liko® Viking® L, Viking® M, Viking® XL, and Viking® 300 Mobile Lifts -

Potential Actuator Damage

FSCA-identifier: Mod 1228

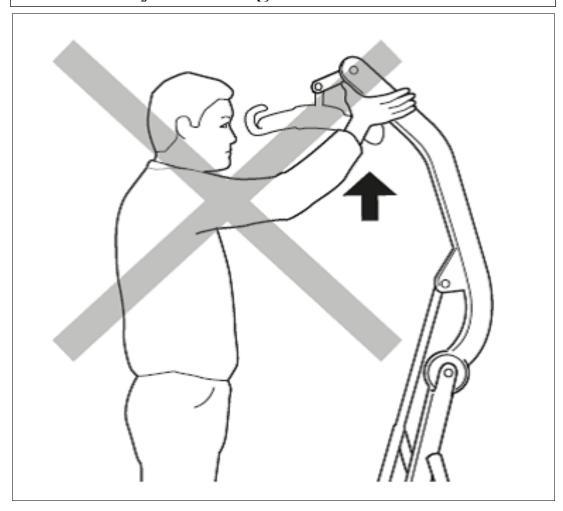
The lift arm assembly is intended to only be lifted by the actuator (lift motor). If the lift arm assembly is manually lifted, the actuator can become damaged and get stuck in the highest position. When the actuator is stuck, the lift cannot be raised/lowered by the lift motor. If a patient is lifted into the sling while the actuator is stuck, there is a potential risk of a free fall of the patient. This hazard could cause minor or potentially catastrophic injuries to a patient if the free fall encompasses the entire stroke of the actuator.

△ Do not raise the lift arm manually!

Hill-Rom requests customers not to raise the lift arm manually since

the lifting actuator can become stuck and/or become damaged. Always use the hand controls or the control box to operate the lift. There are no hazards when using the device as intended. Hill-Rom is updating the product labelling to address this hazard.
