URGENT - FIELD SAFETY NOTICE

**MAQUET HLX 2004-5 DF, HLX 3004-5 DF and XTEN DF
Field Action MSA/2017/002/IU**

Date: September 26th, 2017

Product Issue: Breaking of AC2000 spring arms in use with HLX2004-5 DF, HLX 3004-5 DF and XTEN DF cupolas .

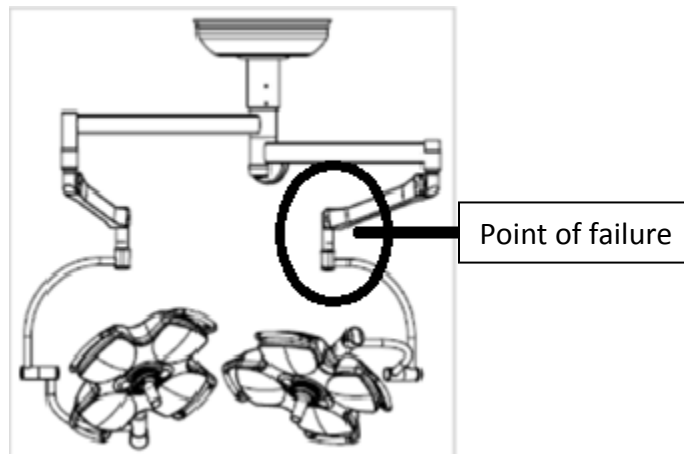
From our investigation it was concluded that there is a low failure rate that only can present itself on the devices of types and production identified in this letter. The issue relates to a crack in the metal of the spring arms that has the potential develop into a break. The devices are over ten years old and even so

This potential for malfunction is caused by fissures near the weld seam at the front pivot of the spring arm. The design of the spring arm was improved in 2006. The devices involved for your market are limited to those listed in the attached Consignee list.

Resolution: MAQUET proposes to replace the affected spring arms with new ones to make sure all devices present in the market are working effectively and safely.

This letter is to inform you of a corrective action that consists of replacing all potentially affected spring arms still in use with new ones. This action will be performed to prevent any possible hazard to persons and equipment.
