## Harvest Healthcare Ltd

### Important Field Safety Notice

**Date 25.01.18**

**HA200 Unipump** - Fitted to the following systems: Opal & Salisbury overlay mattresses. Chatsworth, Opal Plus, Prime comfort active replacements mattresses. Seats cushion system HH20. Systems produced in 2016 and 2017 are affected

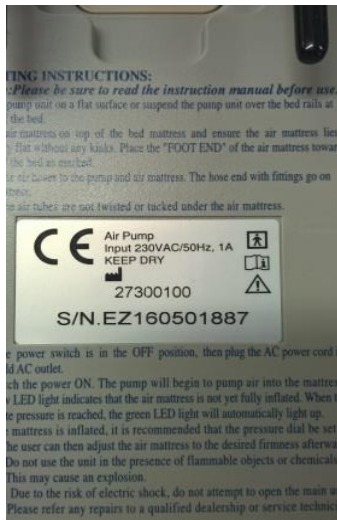
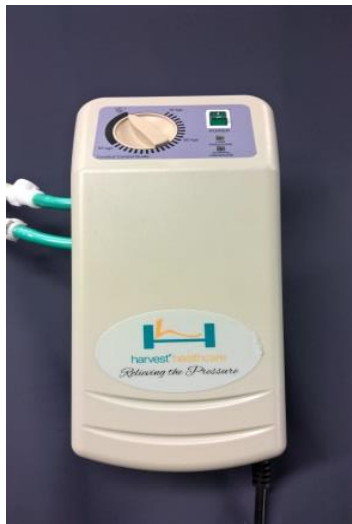
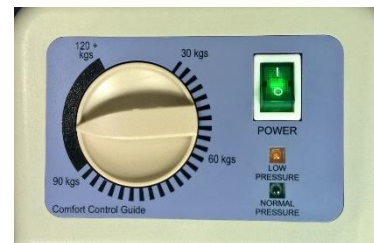
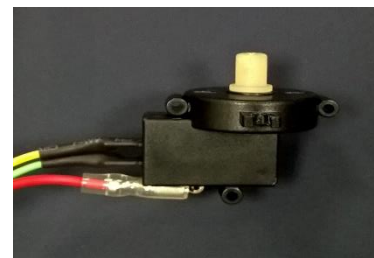
The pump can be clearly identified by looking at the label situated on the underside of the pump. **EZ 16** indicates the year as 2016. These pumps have been supplied as individual units, or as part of active seat cushion and with alternating mattress systems.

It is important to inspect any pump you have regardless of its age to ensure the low pressure indicator is working correctly.

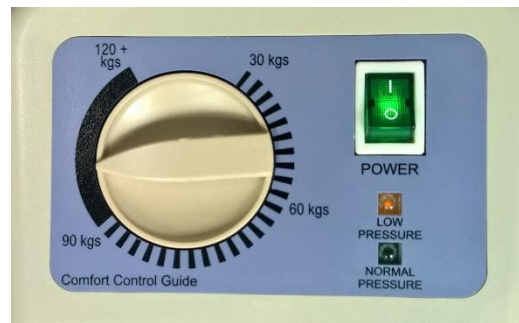
- Disconnect the pump from the mattress system.
- Allow the air to escape from both outlet ports.
- After 10 mins the low pressure light should have activated. This identifies that the pump is in good working order and no further action is required.
- If the low pressure light has not illuminated please follow the procedure below.

- Identify the faulty pump unit and repair or replace the affected item.
- Record the serial number.
- To repair or replace the pump unit contact Harvest servicing.  
HH-Servicing (servicing@harvesthealthcare.co.uk)
- An Updated IFU with recommendations for a weekly check and yearly replacement of the pressure sensor can be obtained from customer service.  
HH-Customer services (customer.service@harvesthealthcare.co.uk)
