### **URGENT FIELD SAFETY NOTICE**

Product Name: **Alaris™ / Asena™ GS, GH, CC, TIVA, PK, Enteral Syringe Pump**  
Product codes with prefix (all variants): **8001, 8002, 8003, 8004, 8005, 8007**  
FSCA Identifier: **RA-2018-03-01**  
Date: **May 2018**  
Type of Action: **Field Safety Notice**

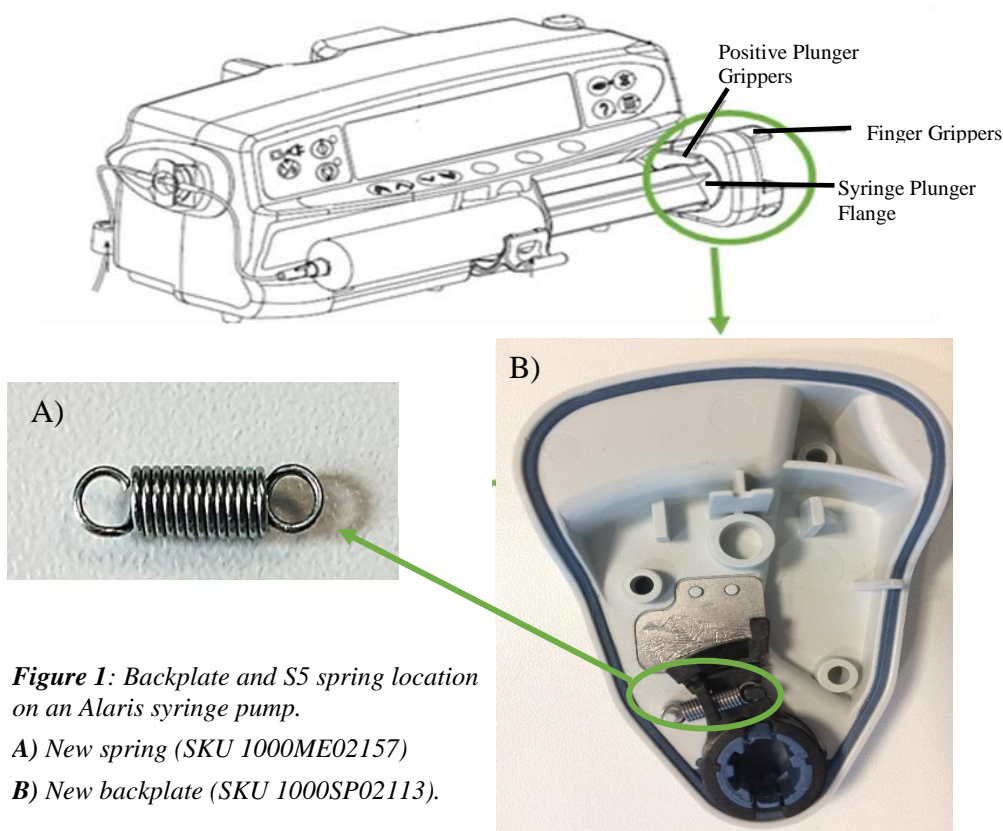
**Figure 1:** Backplate and S5 spring location on an Alaris syringe pump.

The S5 spring is located on the back-plate of the syringe plunger holder and ensures that the syringe plunger flange sits tightly between the positive plunger gripper and the back-plate.

BD has identified that the gripper plate actuating spring (S5), can break and may prevent the gripper fingers from securing the syringe plunger within the plunger holder mechanism which causes a small gap between the syringe plunger flange and the syringe drive mechanism. See Figure 1.

In some circumstances the gap between the syringe plunger flange and back-plate may result in a clinically significant over infusion. Neonatal and paediatric patients, or those receiving critical drugs, at low infusion rates, would be considered to be the most at risk if small volumes of fluids reach the patient due to siphoning.

BD is undertaking a corrective action on its Alaris™ / Asena™ syringe pumps to replace the existing gripper plate actuating spring (S5) design with a new improved design, which is located on the back-plate of the syringe plunger holder as shown in Figure 1 A) and B). This is being undertaken to improve performance and reliability of the S5 spring to reduce the risk of harm to patients. This corrective action supersedes the Alaris™/ Asena™ syringe pump S5 spring replacement, FSN RA-2017-02-02, issued in March 2017.

**A)** New spring (SKU 1000ME02157)

**B)** New backplate (SKU 1000SP02113).

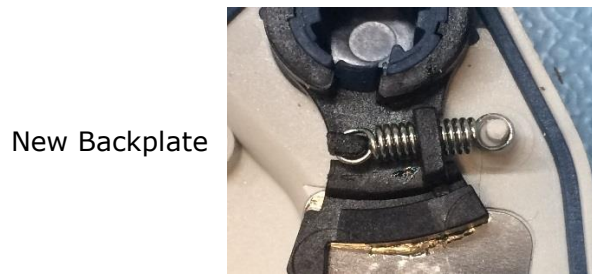
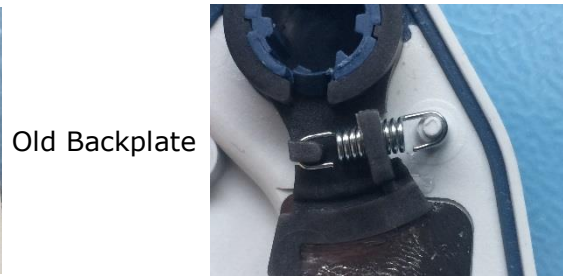
See below for spring identification.

**A Plunger Back Plate Assembly Kit is available, part number 1000SP02113.**
