**IMMULITE® 2000**  
**IMMULITE® 2000 XPi**  
**VersaCell®**  
**VersaCell® X3**

### Level Sensing Associated with Dropped Sample Tubes

Siemens Healthcare Diagnostics has updated the Urgent Field Safety Notice (UFSN) #UFSN2003 dated February 2014. Please discard UFSN #UFSN2003, retain a copy of UFSN #UFSN2004, and return your completed Field Correction Effectiveness Check form from UFSN #UFSN2004.

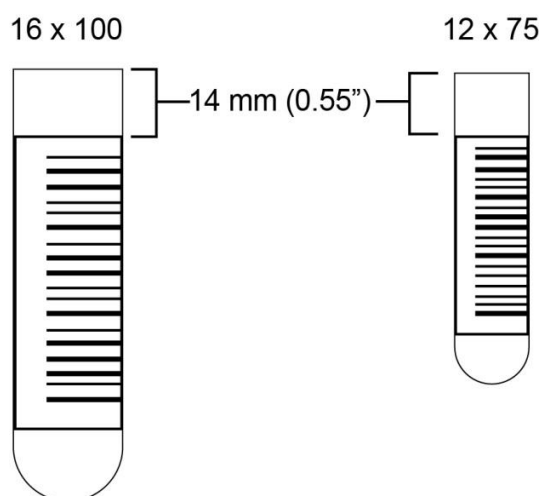
Careful placement of the barcode labels on the sample tubes is critical. In addition to ensuring proper reading of the barcode, proper placement aids in avoiding possible dropped tubes. Sticky residue from barcode label glue or uneven labels from multiple labels on a single tube may cause the tube to stick to the arm gripper fingers.

Place each label with the barcode portion as high as possible on the sample tube, while leaving approximately 0.5" of tube for the gripper to grasp the tube. Refer to the diagram below.

- Place the barcode label at least 14 mm (0.55 inches) from the top of the sample tube and at least 20 mm (0.79 inches) from the bottom of the sample tube.
- Ensure that the barcode label is at least 10 mm (0.4 inches) high.
