Important Medical Device Information

September 2014

This letter is an update to our August 2013 physician communication, which discussed a subset of COGNIS™ CRT-Ds and TELIGEN™ ICDs that had experienced an increased rate of premature battery depletion due to compromised performance of a low voltage (LV) capacitor. With one additional year of clinical experience and analysis, we have identified a second subset of devices that may exhibit compromised LV capacitor performance at a rate that is similar to the August 2013 advisory subset.

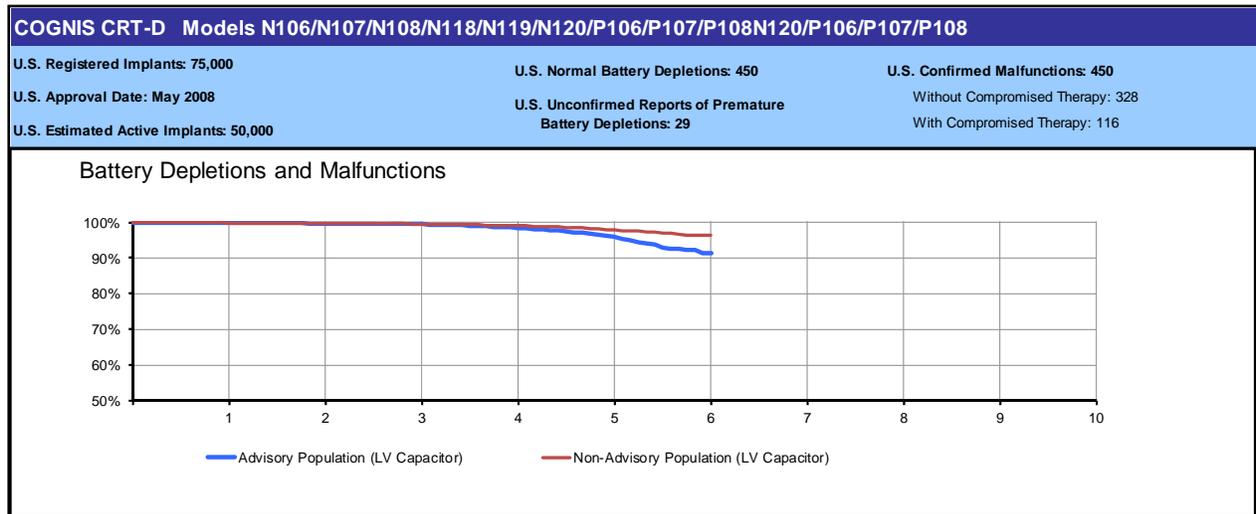
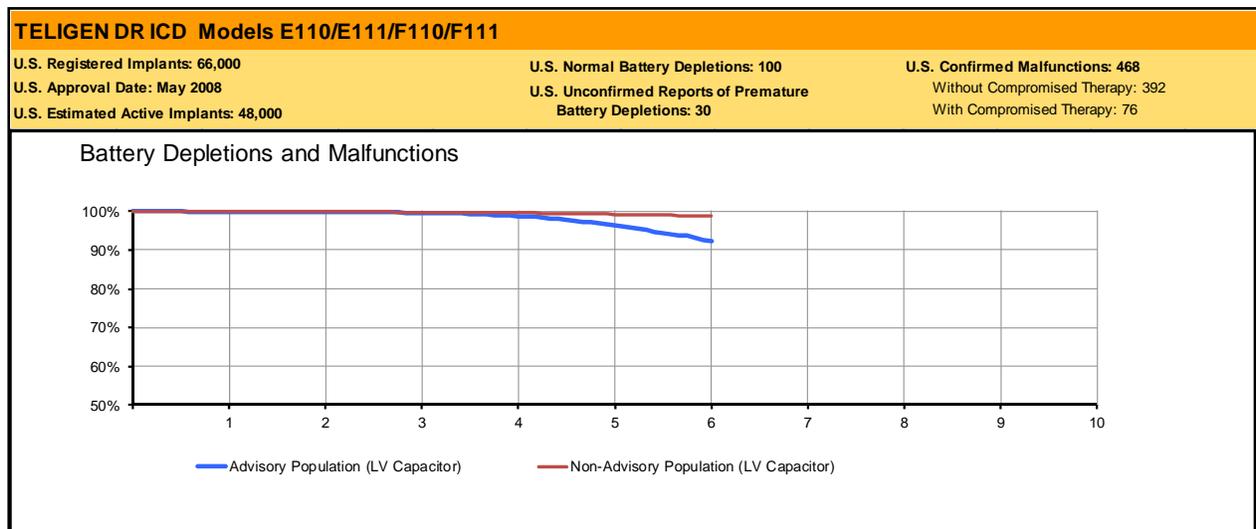
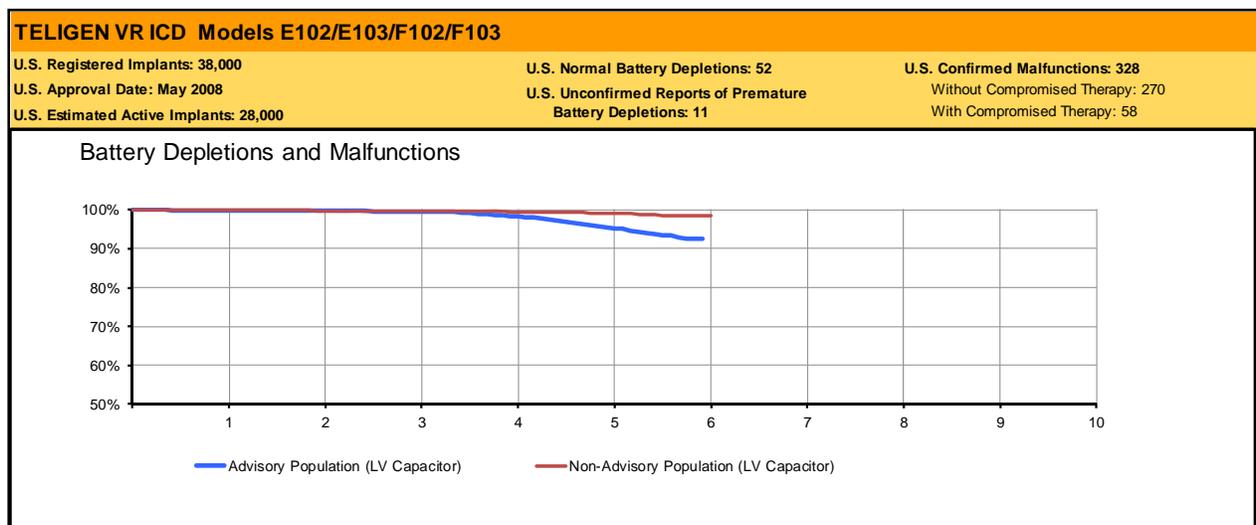
All-cause* Cumulative Survival for devices within and outside of the Low Voltage Capacitor Advisory subset population (United States data)

A total of approximately 267,000 COGNIS and TELIGEN defibrillators have been distributed and implanted since May of 2008. Overall Cumulative Survival, including normal battery depletion, is approximately 95% at 72 months (see Appendix A).

Approximately 22,800 devices identified in the August 2013 communication remain in service. We have identified an additional 27,300 active devices that may exhibit diminished LV capacitor performance at a rate that is similar to the August 2013 advisory population. The projected cumulative rate of occurrence for LV capacitor malfunction within the total advisory population is approximately 2.9% at 60 months. Due to Safety Architecture alerts and timely physician response, the potential for life-threatening harm from loss of therapy is estimated to be less than 1 in 125,000 (0.0008%) at 60 months.

*Includes normal battery depletions and confirmed malfunctions.

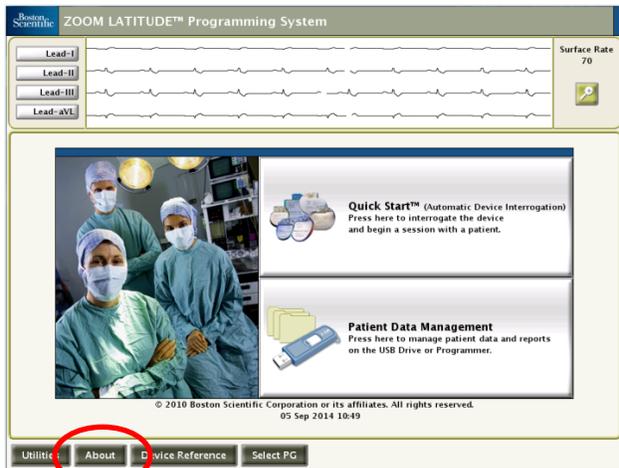
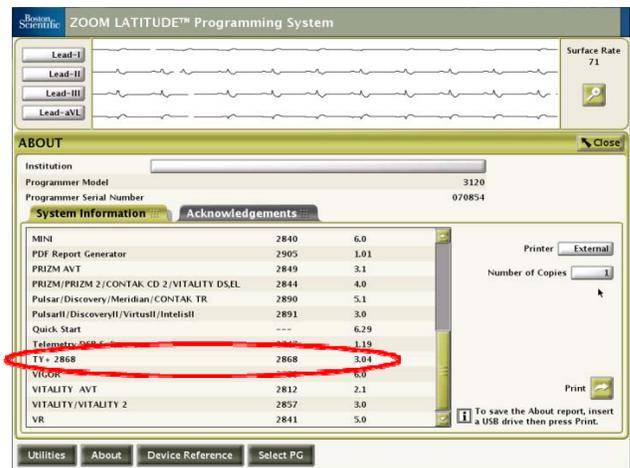
How can I tell if a Model 3120 Programmer has been updated with the new version of software?

- Look for Model 2868, version 3.04 under System Information on the About screen

Boston Scientific has recently introduced updated programmer software (Model 2868, version 3.04) that enhances the effectiveness of the Safety Architecture tools later in device life. We recommend that patients with a device in the advisory population be scheduled for an in-clinic follow-up at first opportunity, but within 3 months, using a programmer with the new software. In-clinic interrogation with an updated programmer will automatically download Safety Architecture software upgrades from the programmer into individual patient devices, enhancing detection of a compromised LV capacitor before therapy delivery is impacted. See Appendix B for additional information on how to identify the current version of programmer software.

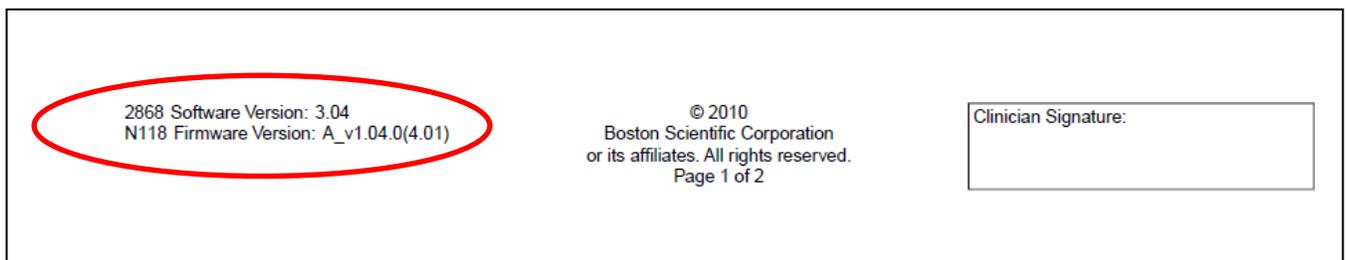
How can I tell if a patient's device has been interrogated with the new version of software?

- For PDF reports printed on an external printer, the programmer software version is located at the bottom of every page.
- For reports printed on the programmer printer, the programmer software version is located at the bottom of the last page
