## **URGENT – Medical Device Correction**

### **Philips IntelliVue MX40 Patient Wearable Monitor Configuration Setting Disables Generation and Delivery of ECG Alarms to PIIC iX**

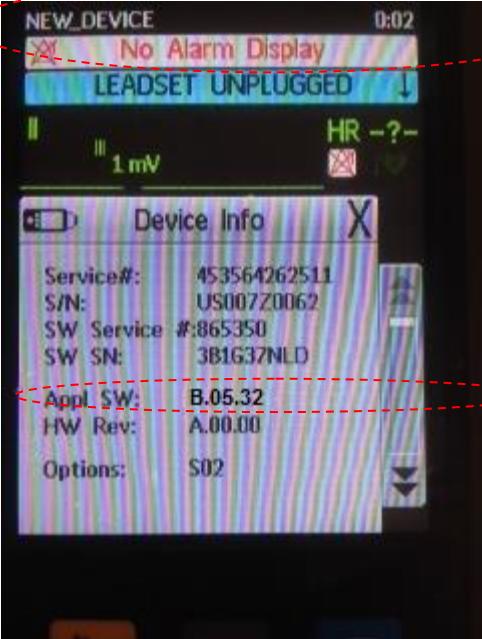
<p style="text-align: center;">Figure 1: Device Info screen indicating software revision</p>
<p><b>ACTIONS PLANNED BY PHILIPS</b></p>	<p>Philips is voluntarily initiating a correction consisting of:</p> <ul style="list-style-type: none"> <li>• Distribution of this Field Safety Notice (FSN).</li> <li>• A Software upgrade for affected Philips IntelliVue MX40 Patient Wearable Monitors.</li> </ul> <p>A Philips Healthcare representative will contact customers with affected devices to arrange for the installation of the software upgrade.</p>
