Philips Ultrasound

FSN79500527

URGENT – Field Safety Notice

Philips S7-3t & S8-3t Transesophageal (TEE) Transducers Temperature Display Issue

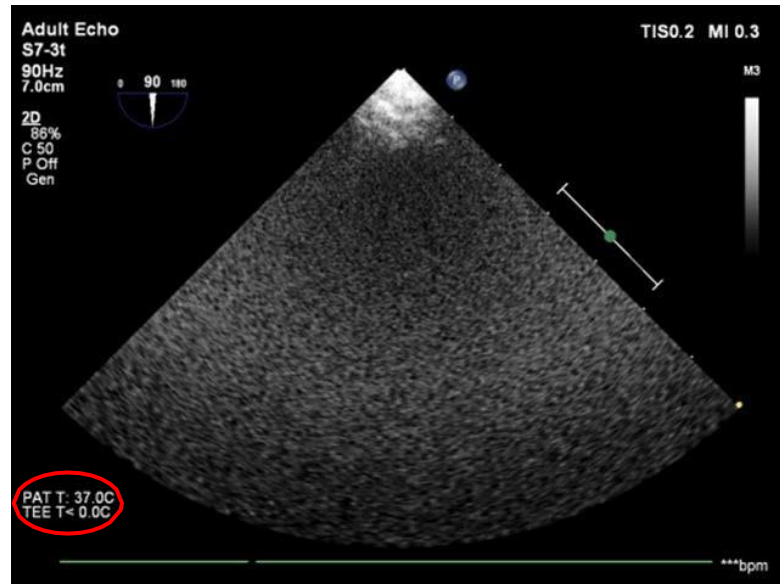
AFFECTED PRODUCTS	S7-3t & S8-3t Transesophageal (TEE) Transducers
PROBLEM DESCRIPTION	A small number of S7-3t and S8-3t TEE transducers were not properly programmed during manufacturing, as a result the system is unable to correctly measure the temperature on the distal tip of the transducer. EPIQ, Affiniti and iE33 systems will show the transducer temperature (TEE T) as <0.0C (<32.0F) on the display. HD11 and CX50 systems will show the transducer temperature (TEE T) as <37.0C (<98.5F) on the display. This issue will result in affected transducers not initiating auto-cool during use, when the transducer distal tip temperature exceeds 41.0°C (105.8°F).
HAZARD INVOLVED	Potential burn of esophageal tissue if the affected TEE transducer distal tip temperature exceeds 42.5°C (108.5°F), and auto-cool is not initiated.
HOW TO IDENTIFY AFFECTED PRODUCTS	<p>The affected S7-3t and S8-3t TEE transducers can be identified by connecting them to an EPIQ, Affiniti or iE33 system, and checking the transducer temperature (TEE T) that appears on the display when enabled. Affected transducers cannot be detected using HD11 or CX50 systems. See instructions below for each system.</p> <p><u>For EPIQ, Affiniti, & iE33 systems</u></p> <ul style="list-style-type: none"> • Connect the transducer to the system and ensure that it is secure and locked. • If the preset is not already selected by default, select it as follows: <ul style="list-style-type: none"> ○ S7-3t - Adult Echo, or ○ S8-3t - Pediatric. • Find the transducer temperature (TEE T) that appears in the lower left corner of the display. • If the transducer temperature on the display shows TEE T <37.0C (<98.5F), then the transducer was properly programmed, and no actions are required. • If the transducer temperature on the display shows TEE T <0.0C (<32.0F), then the transducer was not properly programmed (see image below), discontinue using the transducer and contact your local Philips representative. • If the transducer temperature (TEE T) does not appear in the lower left corner of the display, follow the instructions below to enable it: <p>EPIQ & Affiniti</p> <ul style="list-style-type: none"> • Swipe to the second touch screen • Touch Temp Display to display the temperature display <p>iE33</p> <ul style="list-style-type: none"> • Display the Preset/Transducer touch screen by touching Preset/Transducer • Touch Temp Display to display the temperature display

If you have an EPIQ, Affiniti or iE33 system, verify that all your S7-3t and S8-3t TEE transducers are programmed properly by connecting them to the system, checking the transducer temperature (TEE T) on the display, and following the instructions provided on this letter.

If you determine that your transducer is not properly programmed, discontinue using the transducer immediately and contact your local Philips representative to schedule an appointment with a field service engineer.
