Urgent Field Safety Notice
Product Correction
 Urgent - Immediate Action Required

Date Issued September 16, 2019

Product Name	List Number (LN)	Serial Number	UDI
Alinity ci Level Sensor, Bulk Solution	04S68-02	All	N/A
Accessory kit, Alinity i	03R66-03	All	N/A
Accessory kit #2, Alinity c	03R69-03 03R69-04	All	N/A

Abbott has identified a potential reliability issue with the Alinity ci-series Level Sensor, Bulk Solution (LN 04S68-02). The details of the issue and the potential impact is described below.

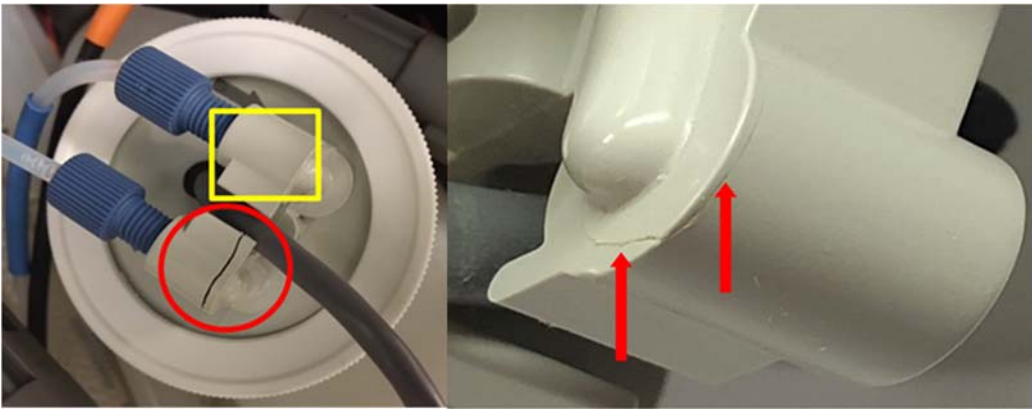
Figure 1. Examples of cracked level sensor (Not Acceptable)

The development of environmental stress on the bulk solution level sensor can cause cracks. Cracks can allow air to enter the fluid line, which may result either a failure to dispense or an incomplete dispense of the bulk solution on Alinity i and Alinity c.

- Area in red circle indicates level sensor crack.
- Area in yellow square indicates undamaged port.
- Area with red arrows indicates cracks.

Abbott has redesigned Level Sensor, Bulk Solution (LN 04S68-02) to improve reliability. The redesigned Level Sensor, Bulk Solution (LN 04S68-03) will be available beginning in the fourth quarter of 2019. You may continue to run the system using part number (LN 04S68-02) until the replacement parts (LN 04S68-03) are obtained by taking the recommended actions outlined in this letter. Once the redesigned Level Sensor, Bulk Solution (LN 04S68-03) is available, Abbott recommends the replacement of the LN 04S68-02 in all positions on the Alinity c and i systems.

- Crack size and location on inlet and outlet ports is variable. See Figure 1.
 - On each level sensor, there is a “knit” line that is a normal outcome from the manufacturing process. The “knit” line is not a crack or defect in the level sensor. See Figure 2.
4. If crack(s) are detected,
 - Replace the bulk level sensor. LN 04S68-02 may be used until LN 04S68-03 is available. For replacement instructions, refer to the Alinity ci-series Operations Manual, Section 9.
 - Review results generated from the last successful quality control.
 5. When the inspection is complete slide the reservoir bottle tray into the bulk solution reservoir area and close the bulk solution door.

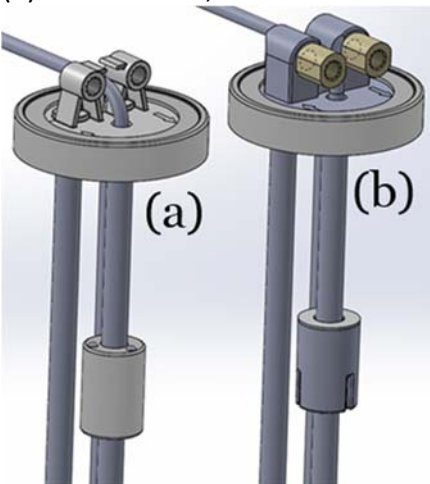
Figure 3. Identification of the Level Sensor, Bulk Solution (LNs 04S68-02 and 04S68-03)

(a) Level Sensor, Bulk Solution LN 04S68-02, (b) Level Sensor, Bulk Solution LN 04S68-03
