# **Urgent Field Safety Notice for:** Dako Autostainer Instruments (AS480; AS100; S3800; S3400):

Update of Autostainer Link Basic User Guide to reduce risks of staining issues due to leakage

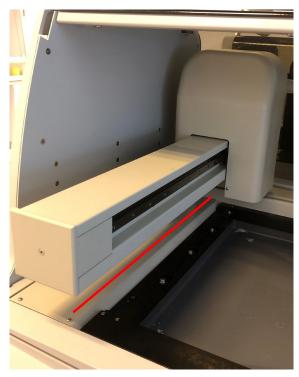
Visually inspect the left plate, area highlighted in red, for signs of unexpected leakage (salt residues and/or liquid) This might indicate leakage from the robotic arm.

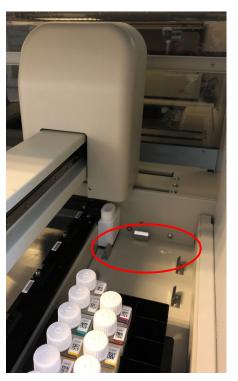
Visually inspect the area around the wash station, area highlighted in red, forsigns of unexpected leakage (salt residues and/or liquid). This might indicate leakage from the z-head or too high pump pressure.
