Date: 12:SEP:2023

**Urgent Field Safety Notice**  
**Sapphire™ Multi-Therapy**  
**Rev 16.10.1 only**

The purpose of this letter is to advise you that Eitan Medical LTD is voluntarily issuing this urgent Field Safety Notice relating to Sapphire infusion pumps with Software Revision 16.10.1 which may fail to detect air in line.

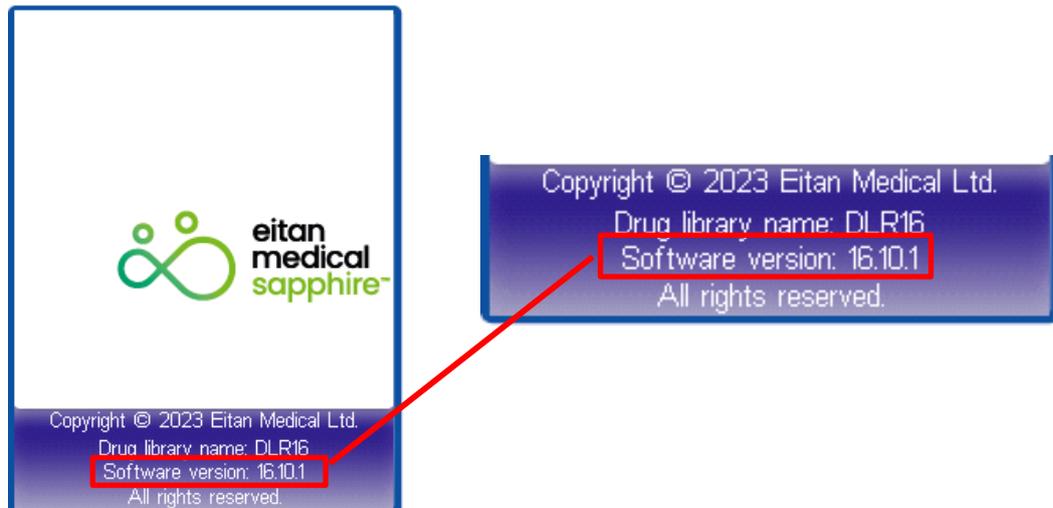
**1.2. How to identify whether you have Software Revision 16.10.1 pumps:**

Turn the pump on and read the software identification at the bottom part of the “power on” screen (first screen after the pump turns on):
