URGENT Field Safety Notice

MR systems terminal connections in the general Mains Distribution Unit (g-MDU) may produce a Thermal Event

19-April-2024

Reference: Terminal connections in the general Mains Distribution Unit (g-MDU) may produce heat triggering the smoke/fire alarm (reference FCO78100582)

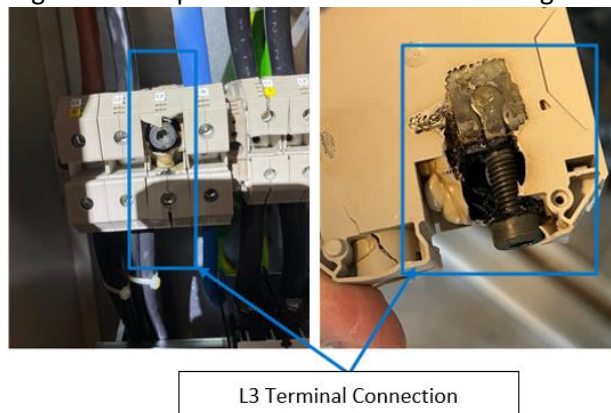
Philips has identified an issue where the g-MDU (global Mains Distribution Unit) L3 terminal connection may become loose creating a hotspot (see figure 1) that may cause smoke/fire to alarm in the hospital's technical room. The g-MDU, located in the technical room, is the single-entry point for the hospital electricity supply and distributes the electricity toward the various cabinets and components of the MR Scanner.

Figure 1. Hotspot on terminal connection of g-MDU

Philips has received five (5) complaints of burnt g-MDU terminal connections, and smoke /burning smell in the technical room associated with the issue. There was no report of injury or serious harm.

Philips will contact you to schedule time for a Field Service Engineer (FSE) to visit your site to inspect the g-MDU connections in the technical room and apply the proper torque to the connection if necessary. (reference FCO78100582). Philips plans to start implementing corrections in July 2024.
