SERVICE ALERT FOR MINI LIFT STAND AID

| Kjaerulff REHABILITATION A/S | | Emne: Bolt replacement Lifting Actuator | | |

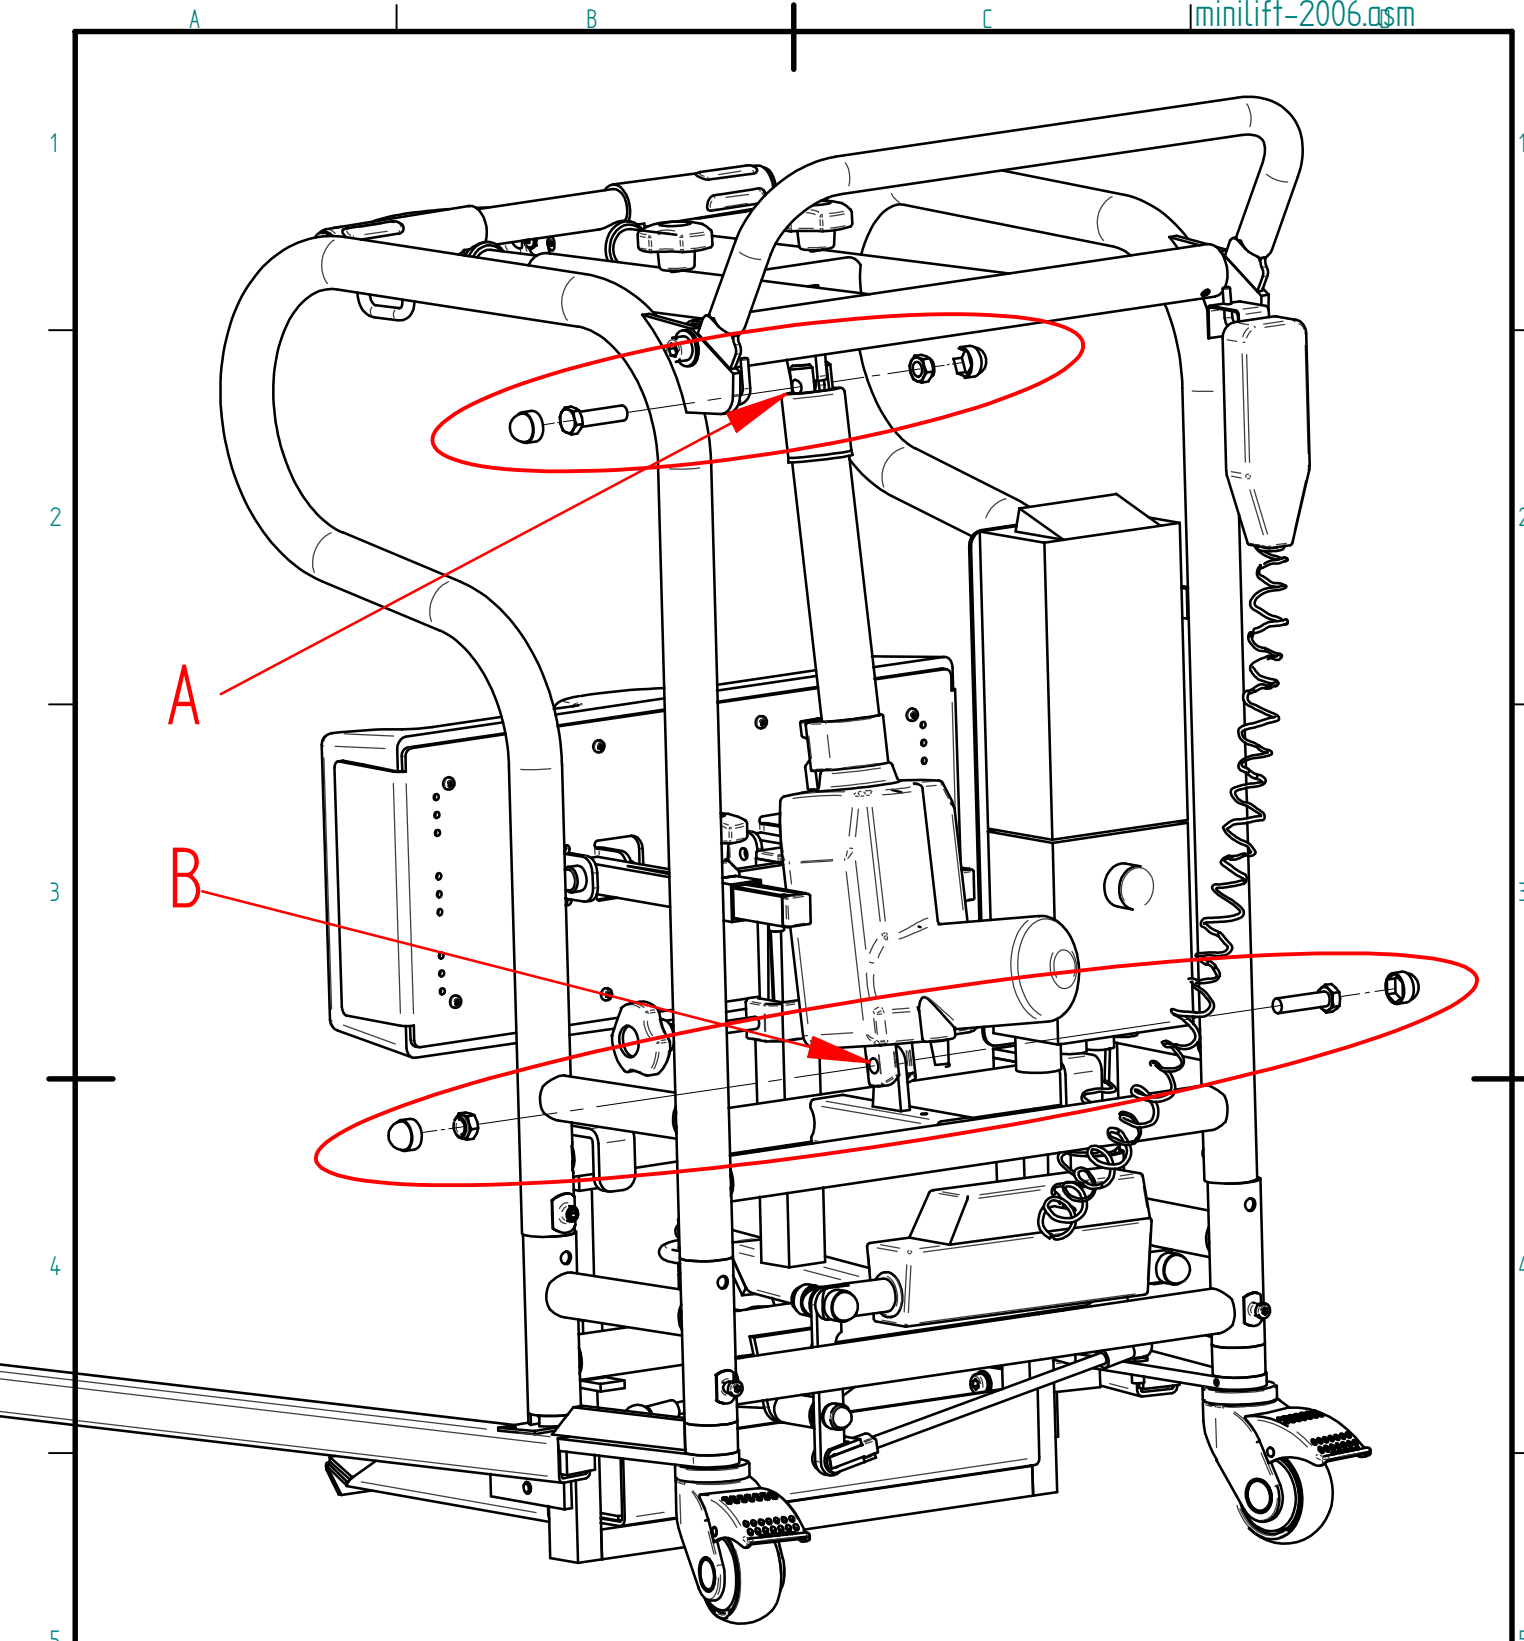
- A: Bolt connecting lifting actuator to lifting arm
- B: Bolt connecting lifting actuator to lower frame

Customers of the Kjaerulff Mini Lift Stand Aid are hereby informed of 2 separate incidents in September 2006 in the United Kingdom, in which the bolt (part A) that connects the lifting arm to the lifting actuator failed due to wear and tear of the brass pin. Please refer sketch indicating the specific parts.

- As a extra safety precaution, we are also instructing customers to replace the bolt with the brass pin (part B), connecting the lifting actuator to the lower frame. There has not to date been any reported bolt failure incident here.

- We are asking all of our Mini Lift customers, to conduct an immediate service check on all pre March 2006 model Mini Lifts still in service. We are instructing that the bolt with the brass pin (part A) be replaced with the all steel bolts supplied along with this letter. We are instructing that this be carried out regardless of the condition of the brass pin, to ensure that potential bolt failure is avoided.
