Advisory Notice – date of issue:

**Huntleigh Healthcare Contoura 880 beds – examination of safety side mounting fabrications.
Type of action required: Potential fitting of replacement parts.**

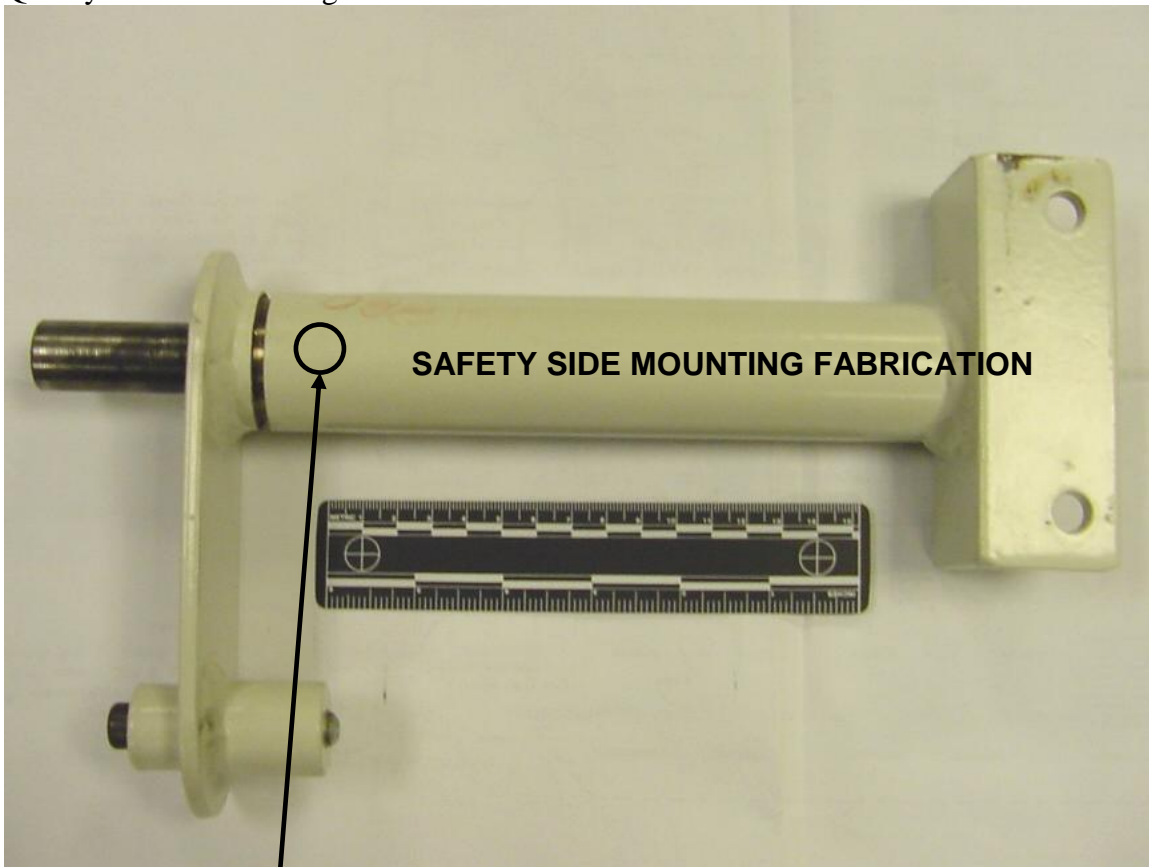
- Identify whether these beds are in use. The model and serial numbers are printed on a label located on the base of the bed, where the power lead connects to the control box. Beds which potentially could be affected have a serial number in the range 167368 to 382938.
- If you have Contoura 880 beds in this serial number range, locate the mounting fabrications that connect the safety sides to the bed frame beneath the mattress platform. There are two mounting fabrications on each side of the bed.
- Examine these fabrications for any signs of weld failure or cracking in the areas shown on Fig 1.

Possible weld cracking in this area.

Note: Crack on the left is much exaggerated in this photo.
The circled area should be examined for cracking.

- If any evidence is found of these failures contact
Huntleigh will provide replacement parts free of charge.
