## Field Safety Corrective Action - 2000 Series Seats

# FIELD SAFETY NOTICE AKW 2000 SERIES SHOWER SEAT

FOR IMMEDIATE ATTENTION by Installers and users of 02000, 02000P, 02200P, 02010, 02010P, 02210P, 02130, 02130P and 02230P MODELS (with or without cushions)

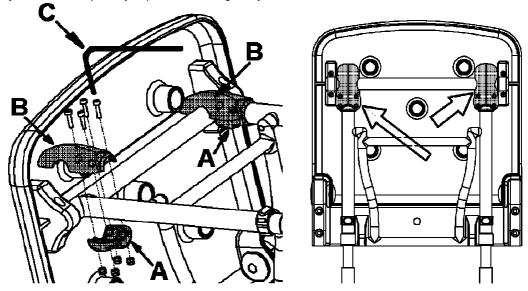
Fig 1 assembling the reinforcement kit

Fig 2 kit correctly installed

- Insert qty 4 "nyloc" nuts into the smaller back moulding "A";
- Insert qty 4 hex socket heads screws through the larger front moulding "B";
- Locate the bigger moulded part over the cross bar and leg at the same time then screw both parts together using the hexagon key "C".

All screws must be **firmly hand-tight using the hexagon key** with screw visible through the retaining sleeve in the nut. Do **NOT** use power tools to fit the screws as these may overtighten the screws and damage the mouldings.
