# Maxi Sky 600 - Infrared (IR) System

DATE:	May 5 <sup>th</sup> , 2008
SUBJECT:	Maxi Sky 600, V4 or V4i equipped with infrared (IR) system
PRODUCT FAMILY:	CEILING LIFTS (FIXED)
DOCUMENT NUMBER:	SAN 04/2008/CA - rev.2
PAGES:	7

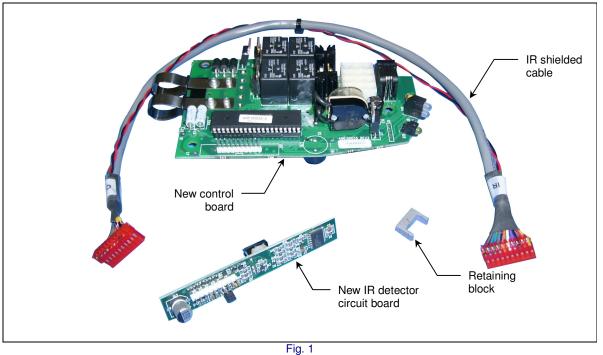
BHM has developed a kit that solves the issues previously mentioned. The components of that kit are depicted in Figure 1. The instructions to make the modification of the IR system are given at the end of this document.

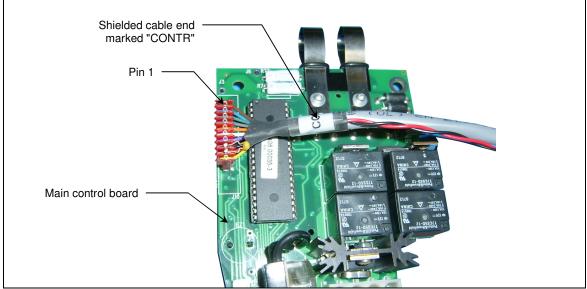
Fig. 3

CAUTION: If the shielded cable connectors are not connected with respect to the cable's end labels and to the pin numbers, the unit will fail to function and/or damage can occur to one or both circuit boards.

- 2) Remove the old main control board and replace it with the new one supplied in the IR kit.
- 3) Connect the shielded cable end marked "CONTR" to the new control board, as shown in figure 3.

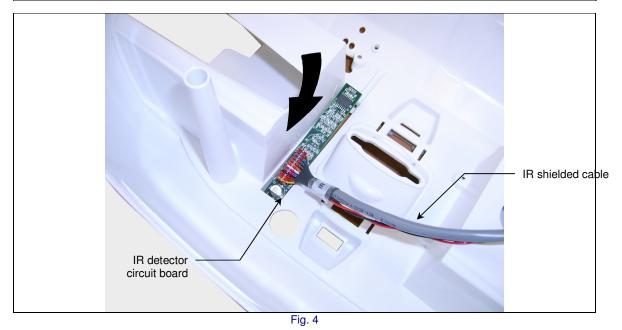
CAUTION: DO NOT BEND THE CIRCUIT BOARD. Manipulate the IR detector circuit board with extreme care as it is fragile and bending it may cause damage to surface mount components.

4) Place the IR detector circuit board in its main shell cavity as shown in figure 4.
