Urgent Field Safety Notice

Harrier Range Technical Manual

Date: 08th May 2012 **Invacare Ref: FSN 043**

Drive Wheels.

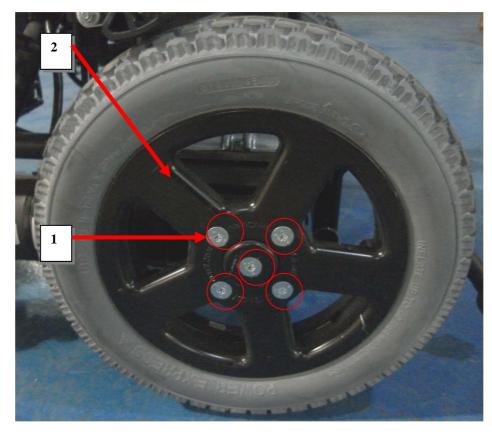
Note: The drive wheel is fixed to the hub by means of five Torx Screws.

- Lift the mobility aid up on one side and get a second person to place a suitably sized wooden block underneath it so that the drive wheel is suspended freely.
- Loosen the five T40 Torx Screws (1).

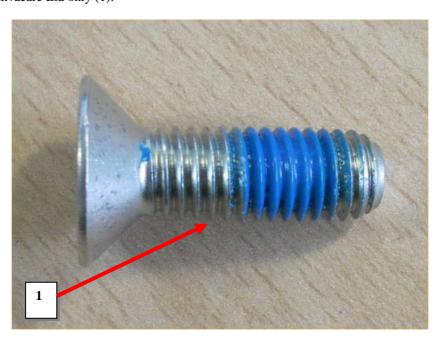
• Take the wheel (2) off the hub.

- Re-fit the drive wheel in reverse order.
- Please ensure the wheel is re-fitted on the same side and is in the same running direction as removed.
- When re-fitting the Torx screws ensure the correct tightening torque as per the table below is applied.

Note: When re-fitting the drive wheel ensure new $*T40 \text{ M8} \times 25 \text{mm}$ Torx screws with Loctite patch are used. Part No 1496138

All removed fasteners must be replaced with new items.
