FIELD SAFETY NOTICE

Date: 2010-02-02
Author: Trina Turcotte, tturcotte@bhm-medical.com
Subject: FSN01/2010/ca.EN
Product group: Floor Lifts
Document number: FSN01/2010/ca.EN
Issue: 1
Case No: NA

SINGLE INSULATION POWER CABLE

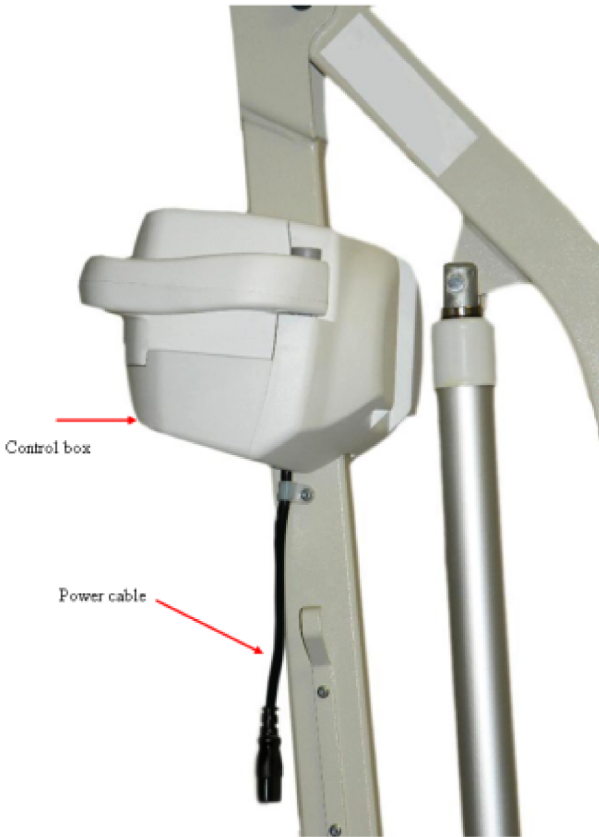
Fig 1: Power cable location

During the assembly of some of the above mentioned products, an improper power cable was installed on the control box. This power cable is single insulated, which increases the risk of premature failure.

A power cable failure could result in a connection between the metal structure of the hoist and the main power. Therefore, there is a risk of electrical shock for the user while the hoist is plugged to an electrical outlet.

The single insulated power cable will be replaced, free of charge, by our dealers/distributors.
