**URGENT – FIELD SAFETY NOTICE**  
**FSCA IDENTIFIER FSN/03/2011/MBD**  
**28 OCTOBER 2011**

**Subject:** Failure of CPR release on Huntleigh Healthcare bed frames

**Products affected:** Contoura® 880 series manufactured between January 1999 & April 2001

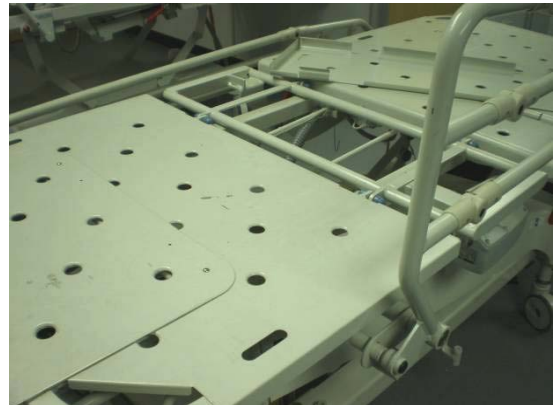
1. Pull off the thigh section deck sheet to allow access to the CPR release mechanism from above.

Check that the release arm is correctly installed as shown below. Note that the photos show the mechanism when the CPR handle is **not** pulled.

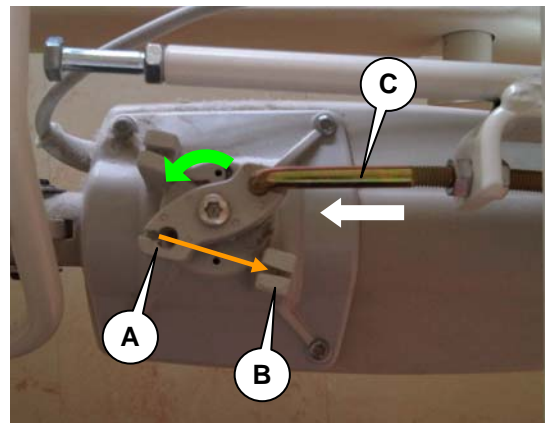
2. This photo shows the top view of the release arm **CORRECTLY INSTALLED.**

The groove in the release arm (A) is in a straight line with the groove in the square post (B), as shown by the orange arrow.

When the CPR lever is operated, the pin (C) pushes the release arm in the direction indicated by the white arrow. The arm rotates in the direction shown by the green arrow; this releases the actuator and lowers the backrest.

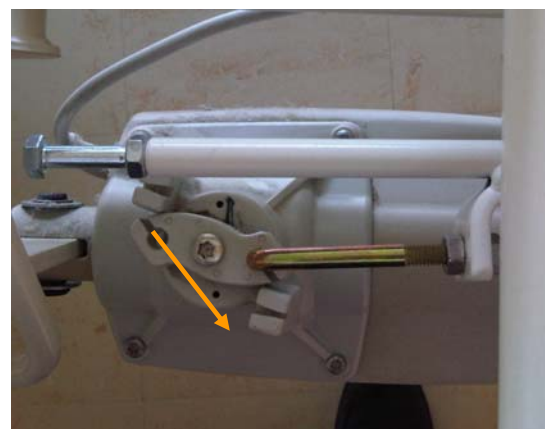
3. This photo shows the top view of the release arm **INCORRECTLY INSTALLED.**

The groove in the release arm is not in a straight line with the groove in the square post.

When the CPR lever is operated, the pin attempts to push the release arm, however because the pin is acting in line with the rotational axis of the arm, it cannot rotate and the actuator does not release.

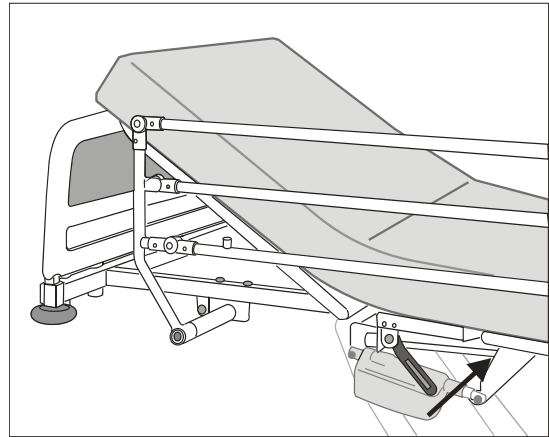
4. When you are satisfied that the modification has been correctly carried out, test the installation as follows:

- Use the handset to raise the backrest to about 45°.
- Pull the CPR handle and check that the backrest lowers quickly (you might need to apply some initial downward force to the backrest; this would normally be provided by the patient's own weight).
- Replace the thigh section deck sheet.

**DO NOT RETURN THE BED TO SERVICE UNTIL YOU ARE SURE THAT THE CPR RELEASE FUNCTIONS PROPERLY!**
