20 April 2017

Urgent Product Correction Notice – FSCA 3445

VITEK® 2 Identification / Antimicrobial Susceptibility Test Cards referenced in Appendix A

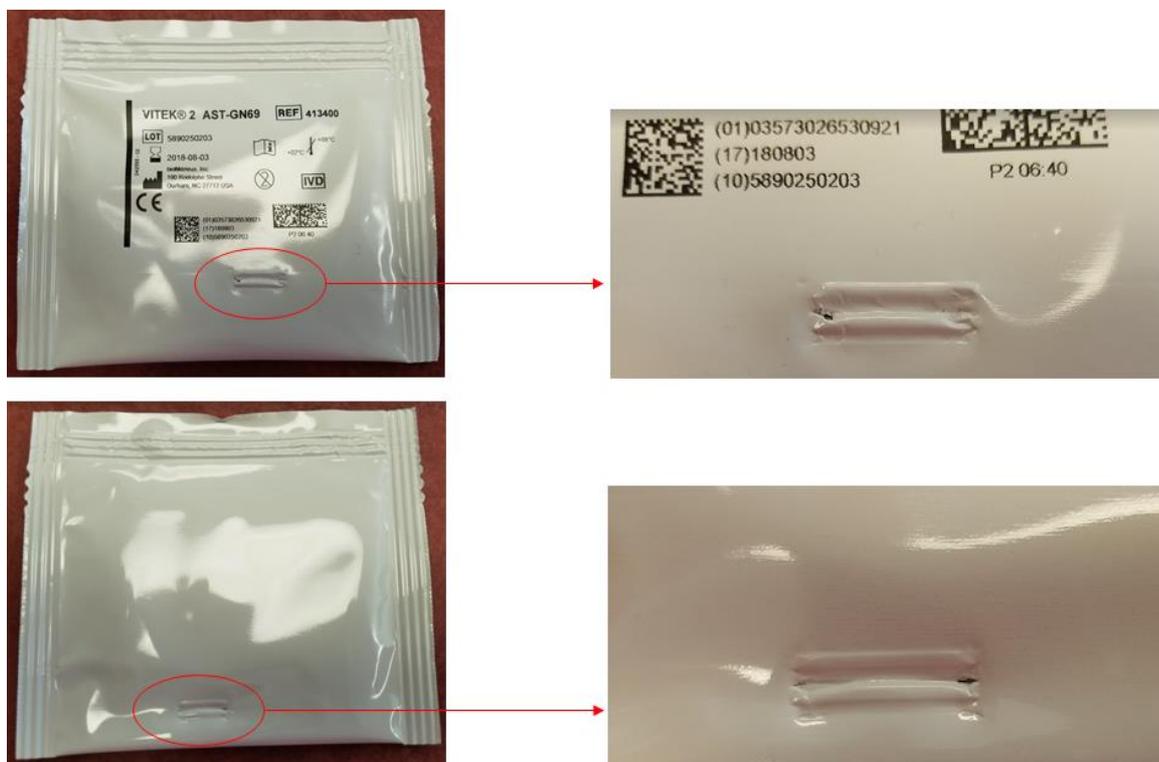
Figure A - Example of Pouch Defect

A potential issue was identified related to the white pouch which contains VITEK® 2 test cards for the product lots specified in Appendix A. bioMérieux has determined that the integrity of some of the VITEK® 2 test card pouches may be compromised. Based on our investigation, a compromised test card pouch can impact card reagents due to the entry of moisture.

The white pouch is composed of five (5) layers of material, four (4) of which are clear. All five layers must be compromised for a pouch to potentially allow moisture to enter the pouch. Upon visual inspection of the pouch, you may notice a small puncture or tear in the packaging at the "stitch seal" (**see Figure A immediately below**). Per product labeling, do not use the card if the pouch (the white protective package cover) is damaged. Based on internal testing, approximately 20% of card pouches exhibited a visual defect; the majority of card pouches with this visual defect maintained pouch integrity, i.e. at least one of the five material layers remained intact. However, 1 in 200 (0.5%) card pouches that passed careful visual inspection failed further integrity tests, indicating the potential for entry of moisture.

1. Check the lot numbers in your inventory against the lot numbers listed in Appendix A.
 2. For impacted lots, visually inspect the test card pouches on both sides for the defect.

- a. If the defect is observed, destroy the associated test card(s) and contact our Technical Service Department on 0044 (0) 1256 480711 or email uktechnical@biomerieux.com for credit.
