FIELD SAFETY NOTICE (FSN)

Fluorocell PLT

might participate in reporting false low measurement results of the PLT-F channel.

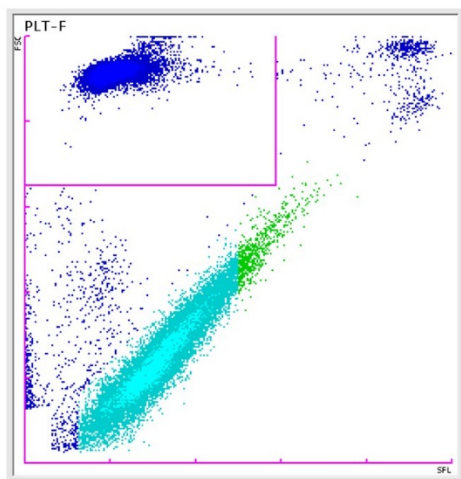
Fig. 1: Sample with a correct PLT-F count

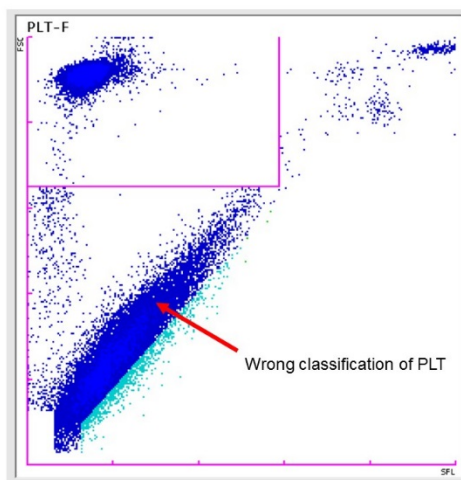
In some cases, the flag 'PLT Abn Scattergram' was triggered. However, in other cases it was not. The false low PLT-F value was associated with a false classification of the PLT population in the PLT-F scattergram.

Internal tests with fresh human blood samples showed a decrease of side fluorescence (SFL) for samples measured in PLT-F channel when the affected lots of Fluorocell PLT were used. As a consequence, the PLT-F population was not counted as PLT and thus the PLT-F results became false low. This is recognisable by a dark blue coloured portion of the PLT population (please see Fig. 2). In addition, the diagnostic parameters IPF (IPF %) and IPF# (IPF count) were potentially affected as well.

| Item | Data | Unit |
|---|---|---|
| PLT-F | 12 * | 10 ³ /uL |

Fig. 2: Sample with a false low PLT-F count

2. Analyse the PLT-F scattergram for abnormalities in the classification of the PLT population, as illustrated in the example above (Fig. 2).
3. Check whether the PLT-F value is significantly lower than the PLT-I value, thereby potentially affecting clinical decisions.

4. If such a significant difference is observed causing a clinical impact, please consider whether the PLT-I value can be used, after verifying the PLT-I histogram. Alternatively, if PLT-O is calibrated, the PLT-O value can be used after verifying PLT-O scattergram (please verify with your local Sysmex representative if PLT-O has been calibrated on your analyser).

5. If during the plausibility check PLT-I, PLT-O and PLT-F values are questionable, perform a smear or measure PLT with the backup system available in your laboratory. For example if PLT-I and/or PLT-F are marked unreliable (*), and the PLT-I histogram and PLT-F scattergram are both abnormal, please verify results with the backup method defined in the laboratory's SOP.

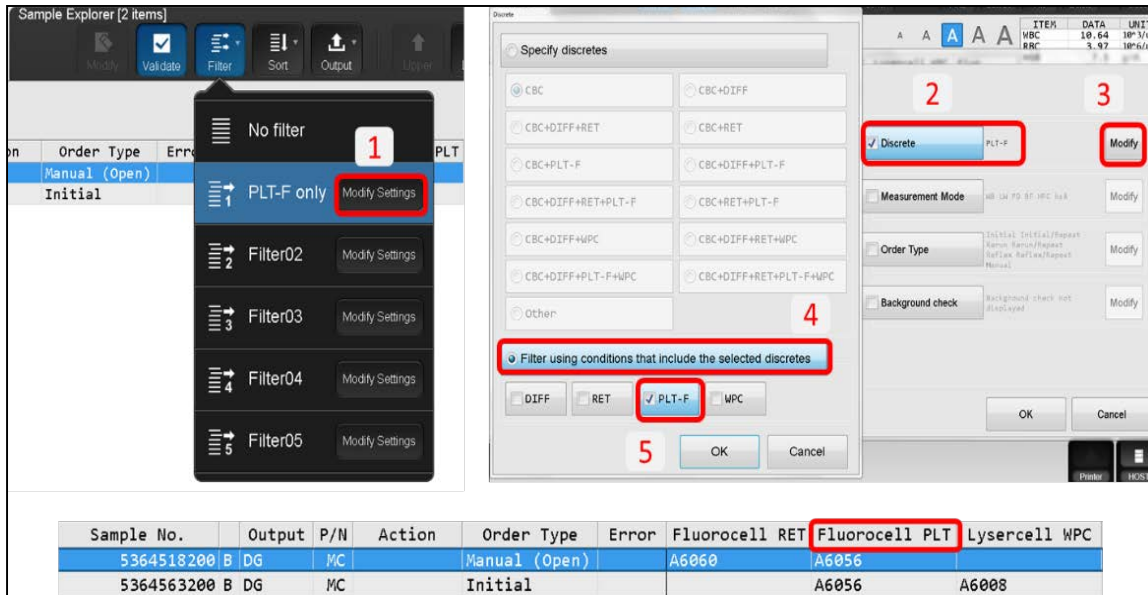
Fig. 3: Filtering of samples with PLT-F measurements. The Fluorocell PLT lot can be seen in the 'Reagent' tab for each measurement

Samples can be easily filtered in the sample explorer to focus on measurements with PLT-F, and samples with 'affected reagent lots' can be identified by using the 'Reagent' tab (see Fig. 3).
