URGENT: FIELD SAFETY NOTICE – MMS-19-1572

T34™ and T34L™ (T60™) Ambulatory Syringe Pumps
All Editions and All Serial Numbers
Type of Action: Advisory Notice

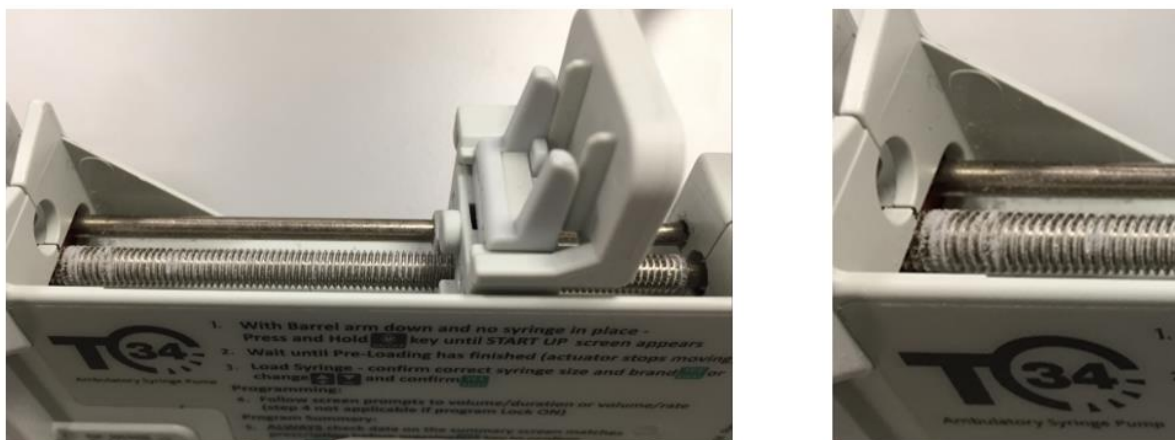
Through Post Market Surveillance feedback, BD/CME has identified that the syringe pump motor block mechanism may be affected overtime by “wear / tear”. This scenario causes **under infusion situations without the pump alarm being generated.**

The issue can be observed when the actuator does not move when the lead screw is rotating, resulting in potentially no pressure on syringe plunger to deliver the syringe contents. The cause of this issue is the actuator nut being worn enough to stop or lose traction on the lead screw due to irregular surface of the lead screw. The “wear / tear” effect can be visually observed as the lead screw is progressively wearing the plastic actuator nut overtime, leaving white plastic debris along the lead screw (see Figure 1 below).

Figure 1: Lead Screw & white plastic debris

BD/CME has revised the Directions for Use (DFU) to include specific instructions for Users to check for plastic white debris on the lead screw during pump set up (Appendix 1). Also, BD/CME has updated the Technical Service Manual (TSM) instructions outlining changes to the maintenance and repair processes to check for plastic white debris on the lead screw and to preventively change the leadscrew and/or motor block assembly where necessary. The pump has to be checked **prior each use for plastic white debris**. Users responsible for pump set-up need to doublecheck that the infusion rate and amount was as prescribed, due to the fact that the pumps will **not alarm** the user in case of underinfusion.

- If there is white plastic debris on the lead screw, this is an indication of wear on the syringe mechanism. Therefore, discontinue use and send the pump for service.

Rockford will replace all affected units (actuator/screw) in the pump or the pump itself.
