URGENT – FIELD SAFETY NOTICE

Arjo Sara Plus lift – Risk of ignition

Date:	31 March 2022
Product Issue:	Risk of device ignition
Affected Product:	Sara Plus floor lifts
Resolution:	Product retrofit by Arjo service
Field Safety Notice:	FSN-POZ-001-2022
Pages:	5
Single registration number of manufacturer in EU:	SE-MF-000000696

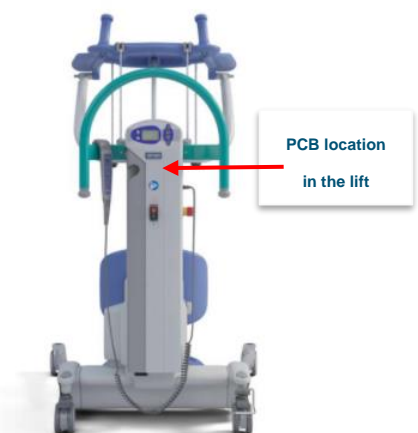
Our sales and service records indicate that you may be in possession of one or more Sara Plus lifts equipped with a PCB (Printed Circuit Board) that is prone to damage during product use. The PCB is an electronic part located inside the lift underneath the cover, as shown below.

It has been found that internal damage of the affected HMX1350-1 PCB may lead to overheating of the part and excessive heat emission which could potentially damage the PCB cover or, in the worst case, cause its ignition.

We will arrange a visit to your facility by an Arjo engineer to complete the Sara Plus correction with a service kit developed by the manufacturer to eliminate the issue.
