URGENT MEDICAL DEVICE FIELD SAFETY NOTICE

Medfusion™ 3500 and 4000 Syringe Infusion Pumps

21st April 2022

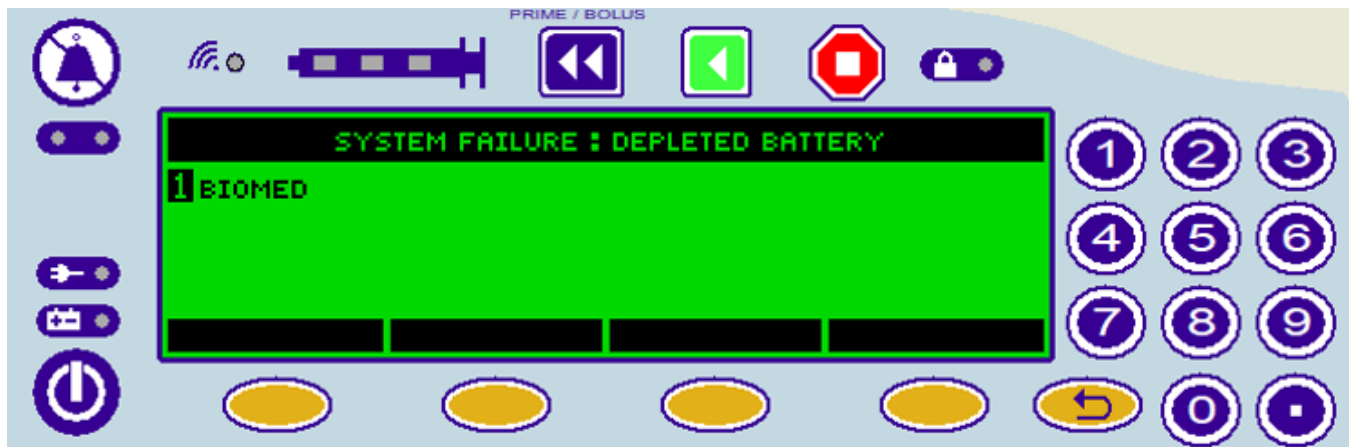
If the pump is unplugged and running on battery, the pump assumes the battery is depleted and sounds an unexpected Depleted Battery (DB) alarm, as shown in the following figure (Figure 1), without the Primary Low Battery alarm being triggered. Even if the battery contains sufficient charge capacity, any ongoing infusion will be interrupted.

Figure 1: System Failure: Depleted Battery Alarm

If the pump is running on battery power and a Battery Communication Timeout (BCT) alarm occurs, the pump assumes the battery is depleted and issues an unexpected Depleted Battery alarm. If the pump is infusing, interruption or delay of therapy may occur as a result. Depending on the patient's condition, the type of medication being delivered, the length of time the therapy is interrupted, and the level of clinical supervision, prolonged symptoms and a potentially life-threatening situation could occur. **To date, Smiths Medical has received reports of four serious injuries related to this issue.**

2. Unless your facility informs you that pump wireless communications are disabled, **be aware that unexpected Depleted Battery alarms may occur** when batteries should have sufficient charge capacity **and that these alarms will stop the infusion.**

3. Unless your facility informs you that they disabled pump wireless communications, **keep the pumps plugged into AC power whenever possible.**
 4. **If possible, do not use the pumps if they are disconnected from AC power.** If you must use the device on battery power, for example, when transporting a patient who has critical medications infusing, **bring backup pumps** to use in case this issue occurs. **Be aware that this issue may occur on backup pumps as well.** Plug the pumps back into AC power as soon as possible.

5. If this issue occurs while a pump is on battery power:
 - Press the Power button to turn the pump off.
 - Plug in the AC power cord, and turn the pump on. You can resume the infusion from the point when the alarm interrupted the infusion by following these steps:

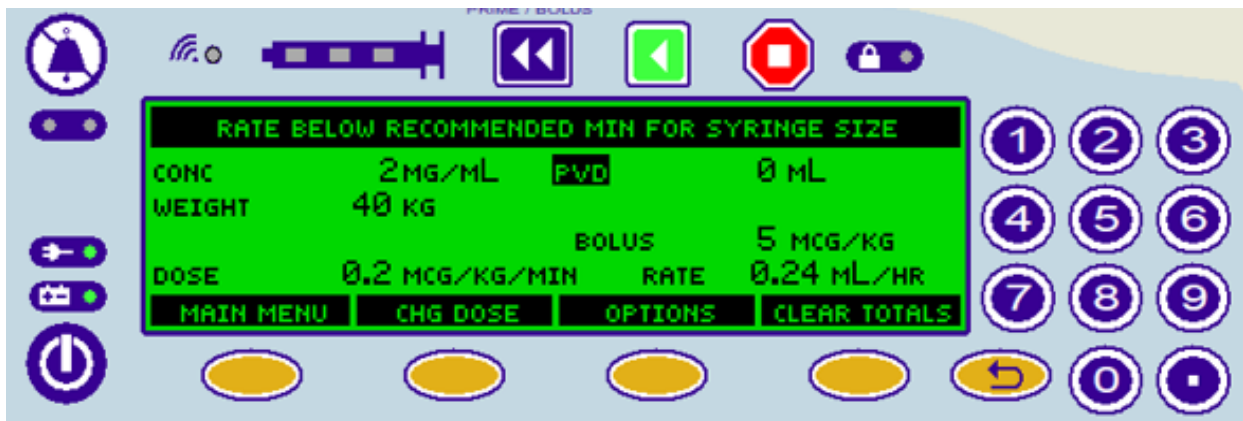
Under certain conditions, **the pump may use incorrect syringe parameters to determine if the programmed rate is below recommended minimum for the syringe size.** The pump will display a false “Rate Below Recommended Minimum for Syringe Size” alarm if this occurs, though the rate may be appropriate for the loaded syringe. The following figure (Figure 3) contains an example of this alarm screen.

When this occurs, the pump uses the Recommended Minimum Rate for the largest syringe of the same brand in the configuration for the Rate Below Recommended Minimum Rate check instead of the Recommended Minimum Rate for the syringe loaded into the pump. Although this issue does not directly impact delivery accuracy, and the pump will display the correct syringe brand and size, **this issue has the potential to affect fluid delivery since it may impact the rapid occlusion detection ability of the pump. “Pressure Increasing” alarms may occur earlier than expected or have false alarms, either with or without an occlusion present.**

Figure 3: False Rate Below Recommended Minimum for Syringe Size Alarm

- If multiple syringes are needed for an infusion, program each syringe as a new infusion.**
- If you see this false “Rate Below Recommended Minimum for Syringe Size” alarm notification, do not continue the infusion: clear the infusion and re-program the infusion with the desired infusion parameters and syringe.

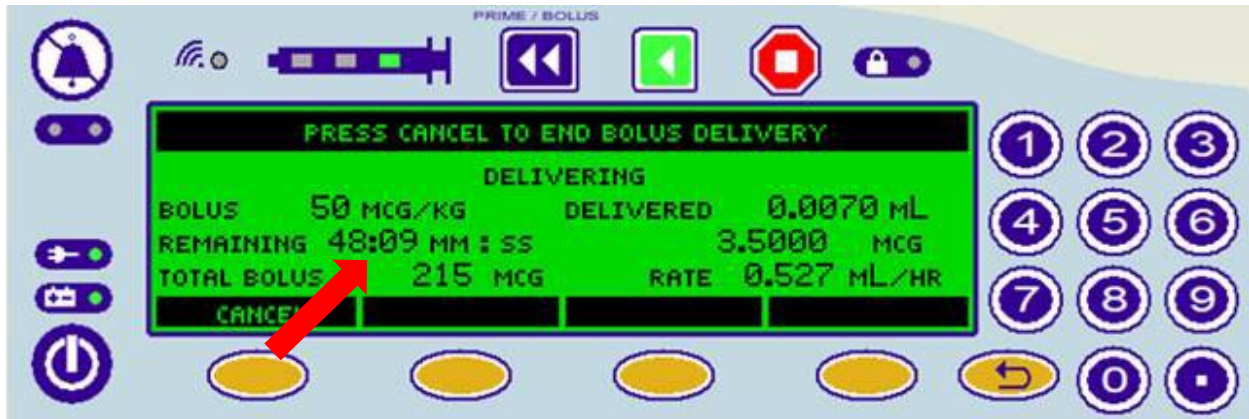
In rare situations, the pump may display an incorrect value for the time remaining during a **Bolus Dose or Loading Dose infusion** (see Figure 4). If this issue occurs, the **pump will infuse correctly to the intended infusion time even though the displayed time remaining is incorrect**. The pump appropriately transitions to continuous infusion upon completion of the Bolus Dose or Loading Dose as programmed.

Figure 4: Example of Incorrect Time Remaining. “REMAINING 48:09 MM:SS” should be displayed as “REMAINING 04:09 MM:SS”

- When programming and monitoring Bolus Dose and Loading Dose infusions, verify that the displayed time remaining on the screen is the same as the intended time.

- If the displayed time remaining is incorrect, your options include:**
 - Depending on the clinical scenario, including consideration of the patient condition and the medication, use your clinical judgement to determine if it is appropriate to continue the infusion with the incorrect remaining time displayed, while closely monitoring the Bolus or Loading Dose to verify that the infusion converts to the continuous infusion at the intended time.

- Program the intended Loading Dose or Bolus Dose as a separate intermittent infusion. When the infusion completes, program the continuous infusion.
 - Be aware that the issue will recur if the pump (or a replacement pump) is programmed with the same Bolus Dose / Loading Dose, and continuous infusion.
