Welch Allyn, Inc. 4341 State Street Road Skaneateles Falls, NY 13153 USA	URGENT: Field Safety Notice	FA-2021-05-001-SKF-004
---	------------------------------------	------------------------

Braun® ThermoScan® Pro 6000 Ear Thermometer

Potential risk of probe tip overheating

FSCA-identifier: FA-2021-05-001-SKF-004

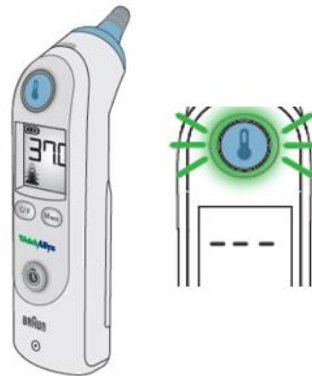
Figure 1

Our investigation has confirmed that the probe tip overheating is the result of fluid ingress. Fluid ingress causes the sensor to behave inconsistently, which does not allow the built-in safety mitigation (turn off the heating element) to work correctly. The majority of the devices which experience overheating of the probe tip show one of two behaviors at time of power up:

1. The ring around the measurement button will show a green blinking or flashing light instead of a ready state (solid green light).
2. The device requires multiple power-ups prior to going to ready state (solid green light). See Figure 1.

2. Do not use the device if the ring around the measurement button shows a green blinking or flashing light instead of a “ready state” (solid green light) and contact Hillrom Customer Service to report this issue.
3. Do not use the device if the device requires multiple power-ups prior to going to “ready state” (solid green light) and contact Hillrom Customer Service to report this issue.
4. If you experience an overheating probe tip, do not use the device and contact Hillrom Customer Service to report the issue.
5. Complete the attached response form and return to HillromSKF004OUS@stericycle.com within one month.
