Welch Allyn, Inc. 4341 State Street Road Skaneateles Falls, NY 13153 USA	URGENT: Field Safety Notice	2021-07-001-MKE-005
---	------------------------------------	---------------------

ELI@280, MLBUR280 and BUR280 Electrocardiographs

ELI@280 resting electrocardiograph - Patient mismatch/Software Upgrade

FSCA-identifier: 2021-07-001-MKE-005

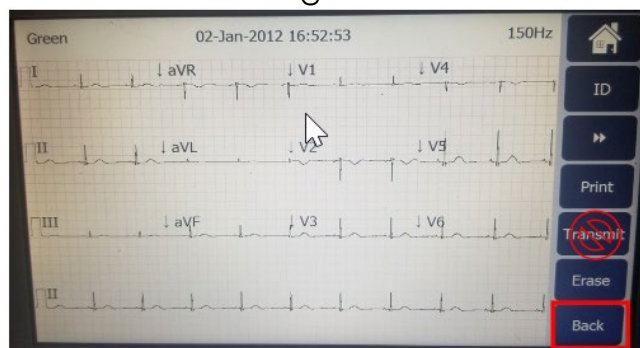
The following workflow can result in the transmission of a different ECG record than the record intended to transmit. The record transmitted contains accurate clinical information, however it is not the record intended to be sent.

1. An ECG is acquired for Patient A and stored to the cardiograph.
2. An ECG is acquired for Patient B and stored to the cardiograph.
3. The ECG record associated with Patient A is retrieved from memory and any Patient Demographic information is edited.
4. After editing, the "Resting ECG" screen is presented as shown below. Figure 1
5. Pressing the TRANSMIT button from this screen (following any Patient Demographic edit) will transmit an ECG record other than for patient A. (see figure 2, which shows the Resting ECG screen).

If an ECG record is retrieved from the patient directory for a Patient Demographic edit to be performed, once the information has been edited and the screen above (Figure 1) is presented, do not press the transmit button. Instead, press the BACK button which will SAVE the changes to memory and present the user with the following screen, where the SYNC button can be used to transmit the desired record to the configured destination.

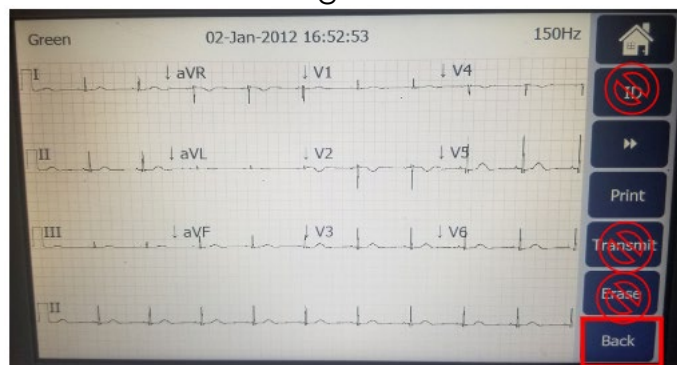
Figure3

The following workflow has been identified as resulting in the transmission of a “hybrid record” that contains the patient demographic information for patient A and the ECG morphology and measurement data for patient B.

1. An ECG is acquired for Patient A and stored to the cardiograph.
2. An ECG is acquired for Patient B and stored to the cardiograph.
3. The ECG record associated with Patient A is retrieved from memory and ID information is edited.
4. After editing, the “Resting ECG” screen is presented as shown in Figure 3.
5. The user decides to make another ID Edit without leaving the “Resting ECG” screen and presses the “ID” button - Figure 3.

6. After the second edit is performed, the “Resting ECG” screen is once again presented as shown above.
7. Pressing the TRANSMIT button from this screen (following two ID edits in a row as defined above) will transmit an ECG record with the patient demographics
