Cover letter to customers, homecare providers and distributors

Subject: Field Safety Corrective Action for Breas Ventilator Trolley (REF 007384)

Reference: CAPA-149 / 6.6.2-2022-7340

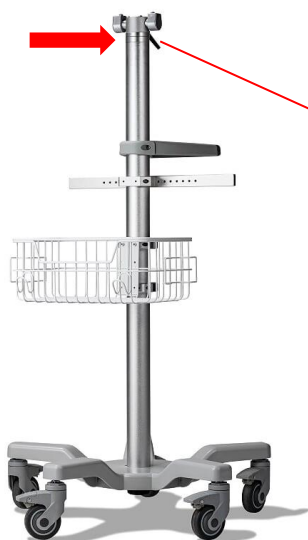
Figure 1 Breas Ventilator Trolley (REF 007384)

Breas Medical has received market feedback that there may be a possibility that the ventilator mounting brackets for the Vivo 55/65, Vivo 45/45 LS, Vivo 1-2-3 and NIPPY models can become detached from the Breas Ventilator Trolley (see Figure 1 below) whilst in use.

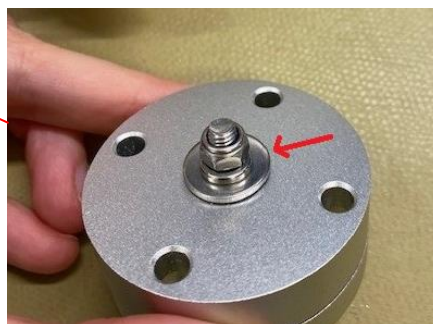
Figure 2 Swivel assembly with metal washer

Breas Medical urgently investigated this feedback and concluded that there is a possibility, that the swivel assembly may not have been manufactured according to Breas Medical's specification and it may not contain the metal washer as shown in Figure 2. The issue may affect Ventilator Trolleys delivered between 11 June 2020 and 3 December 2021.

Breas Medical's recommended solution (Option 1) is to provide Inspect and Repair Kits (REF 008591) to all those potentially affected by this notice. The Inspect and Repair Kits are used to inspect the Trolley to determine if remedial action is required, and to replace the defective part if needed.

For customers who do not wish to inspect the Trolley swivel assembly, Breas Medical can arrange replacement of the trolley pole including the swivel assembly (Option 2). Breas Medical advises that this option will likely involve more effort than Option 1.
