Product/Trade Name:	ARTIS icono biplane, ARTIS icono floor, ARTIS pheno	EU-SRN	DE-MF-000006122
Model Number:	11327600, 11327700, 10849000	E-mail	advancedtherapies-fsca.team@siemens-healthineers.com
		Date	February, 2022
		Corrective Action ID	AX003/22/S, AX004/22/S

## Customer Safety Information (CSI) for Field Safety Corrective Action

**Subject: Software update of ARTIS systems with software version VE20 to VE21**

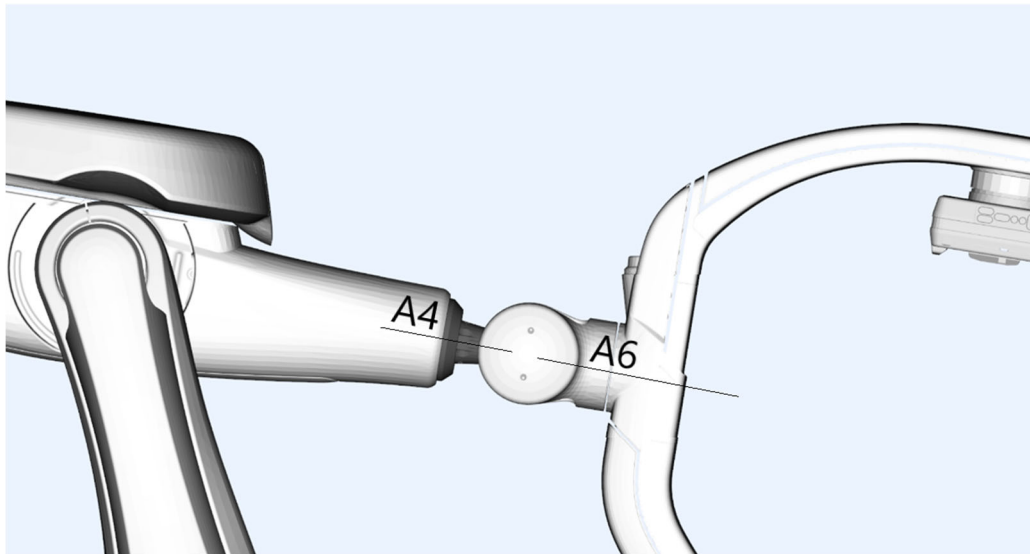
In special, clinically untypical positions of the ARTIS pheno stand (see figure 1) the robot may move into a so called singularity position, where the movement may get stopped and blocked.

Figure 1: C-Arm position in singularity

If this issue occurs, all stand movements are blocked and can only be reactivated by a field service engineer. Depending on the status of the intervention, the limited functionality may not be sufficient to continue with treatment as planned. This may result in a situation where it is necessary to cancel clinical treatment or to continue treatment on an alternative system.

The issue has been identified in the field in combination with a suboptimal system adjustment only. The root cause for the blocked stand movement is a software issue.

Please consider the need to establish emergency procedures to manage situations related with the failure of your ARTIS system according to the User Manual.

The software will be updated.
