URGENT Field Safety Notice

MR systems with 60cm wide bore

Quadrature Body Coil (QBC) seal adhesive failure may result in exposure of sharp edges

28-December-2023

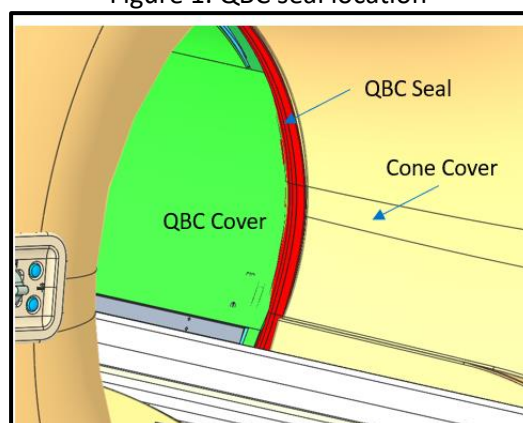
Figure 1. QBC seal location

The Quadrature Body Coil (QBC) seal adhesive may fail creating sharp edges that may come in contact with patients. The QBC seal may become loose as the patient table travels in a horizontal motion in and out of the system bore. The QBC seal (Figure 1) is a rubber seal that is glued between the cone cover and QBC cover and functions to prevent sharp edges of the QBC cover from contacting patients during an examination.

Philips has received three (3) reports of adverse events associated with this issue, one patient received a cut on the hand, one patient's hair became entangled resulting in a scalp injury, and one patient received lacerations to the upper left arm.

If the QBC seal becomes loose during the scanning process, the risk to the patient may include one or more of the following: skin abrasions, bruises, lacerations, hair loss/entanglement, and tissue injury.

- As part of the preparation before a patient scan:
 1. Inspect the QBC seal for separation between the cone cover and QBC cover.
 2. If QBC seal is found detached or loose, **Stop-use immediately**.
 3. Contact your local Philips service representative.
- If QBC seal becomes loose during a patient scan:
 1. **Immediately stop scanning** and carefully remove patient from the system.
 2. Contact your local Philips service representative.

Philips will contact you to schedule a time for a Field Service Engineer (FSE) to visit your site and replace your system's QBC Seal (reference FCO78100573). Philips plans to start implementing corrections in Q3 2024.
